Service Bulletin

Subject: Round Dark Stains on Roof Paint Center Rear Area

Models: 2010-2017 Chevrolet Equinox
2010-2017 GMC Terrain
All without RPO CF5 Sunroof

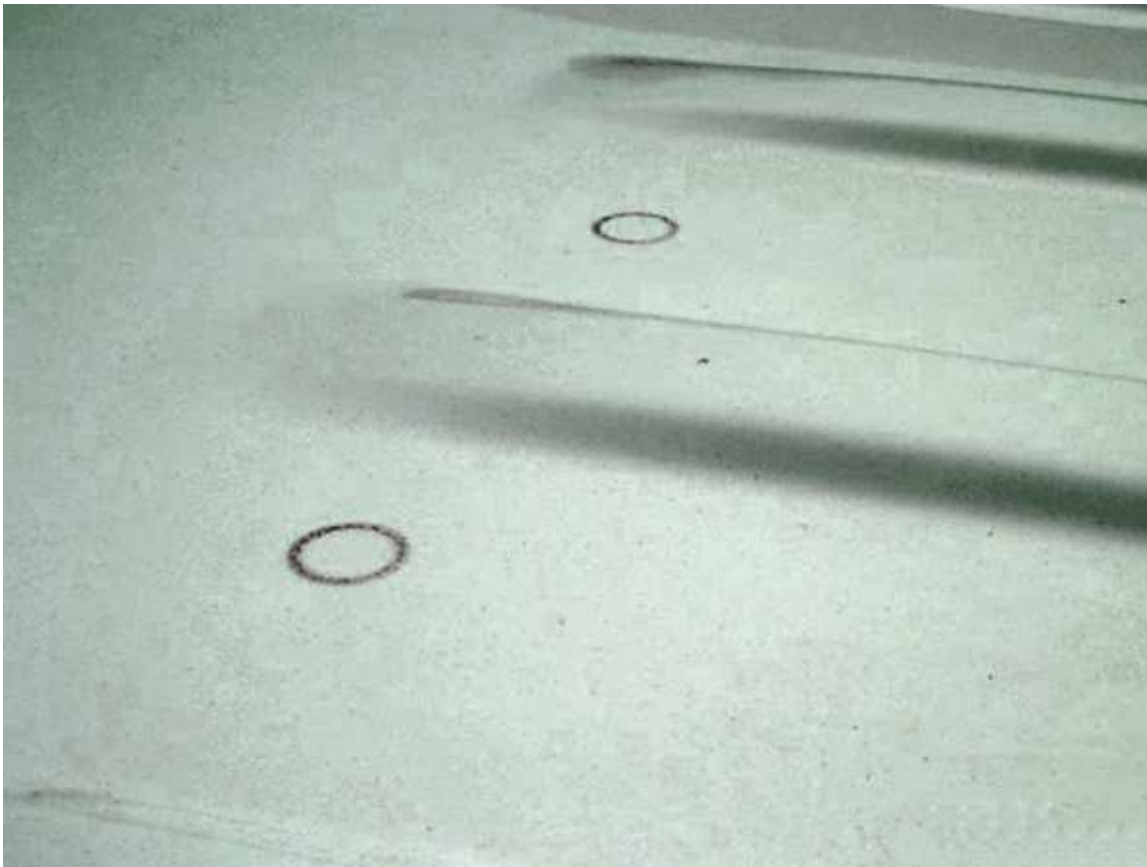
Some customers may comment that two dark circles of paint discoloration have formed in the center of the exterior roof panel. This condition is most noticeable on light colored vehicles.

This condition may be caused by the headliner retention magnets attracting steel or iron dust. This dust, combined with moisture, causes a dark/rust colored stain that does not wash off during routine vehicle washing.

Use the following steps to remove the stain and install two metal plates (latch striker spacers) inside of the roof. These metal plates will isolate the magnetic attraction from the exterior of the outer roof panel.
