Bulletin No.: PI1384A

Subject: Semi-Annual Preventative Maintenance Check for Police Vehicle Cooling Fans

Models: 2006-2016 Chevrolet Impala Limited Police Vehicle

Equipped with RPOs 9C1 and 9C3

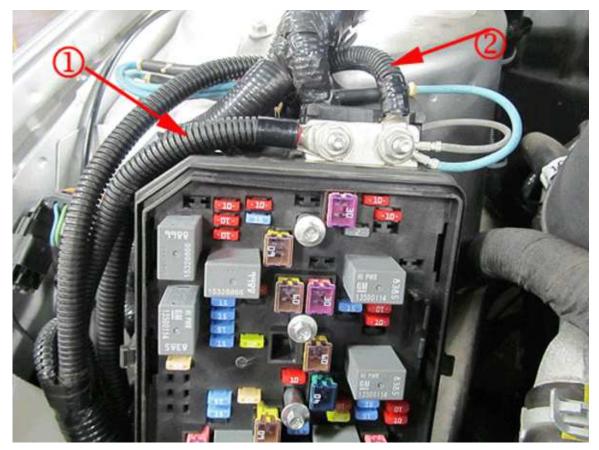
Vehicles equipped with remote harness with relays not in the UBEC – Check the amp draw by directly placing the Mid-Range Amp Probe clamp on the positive wire (1), (2) going to each fan individually.

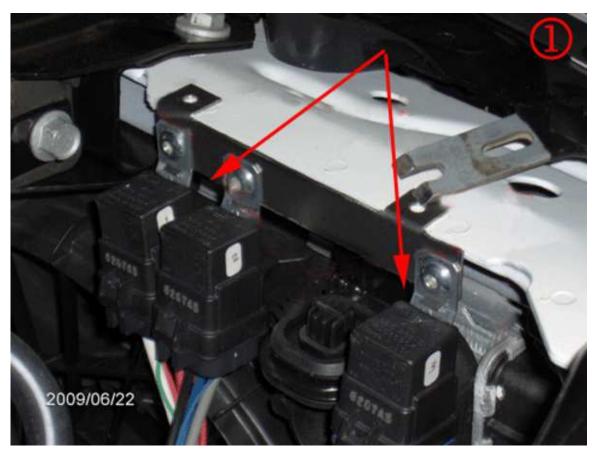
1. Located behind the headlamp

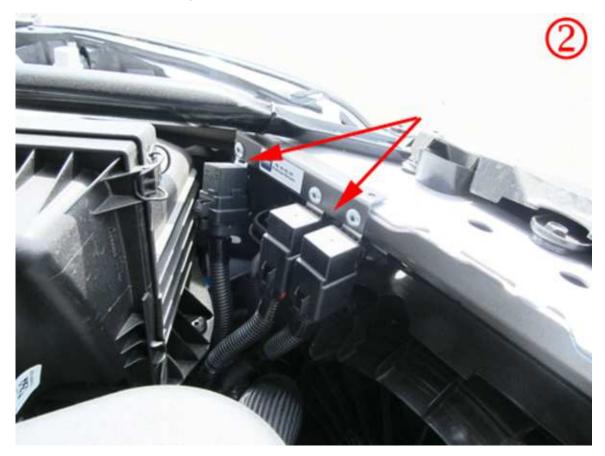
2. Located on the radiator support

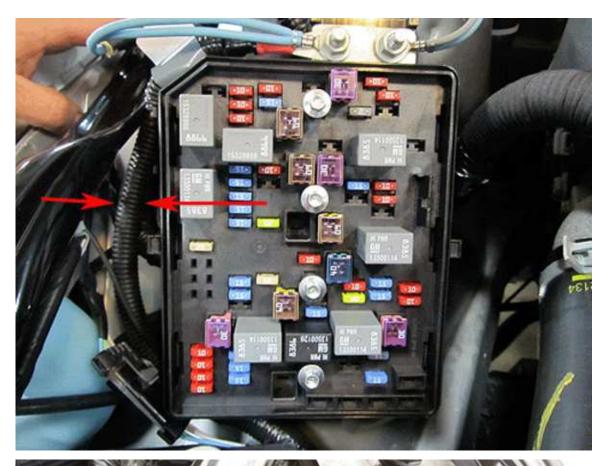
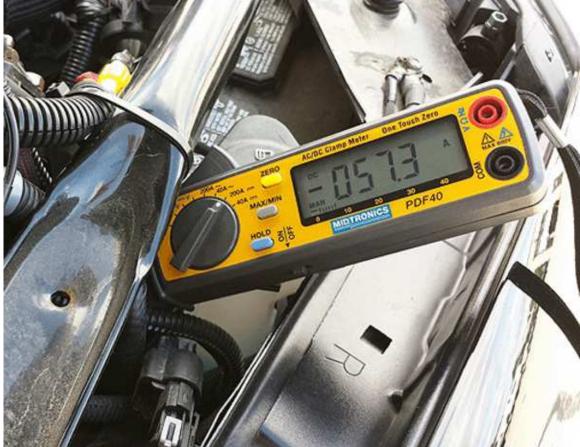
Vehicles NOT equipped with remote harness – Check the cooling fan motor amp draw using Mid-Range Amp Probe at the wiring block as shown below.

The starting amperage may be between 16-18 amps at this location with the vehicle running. When each fan is turned on, it will "jump" up in reading.

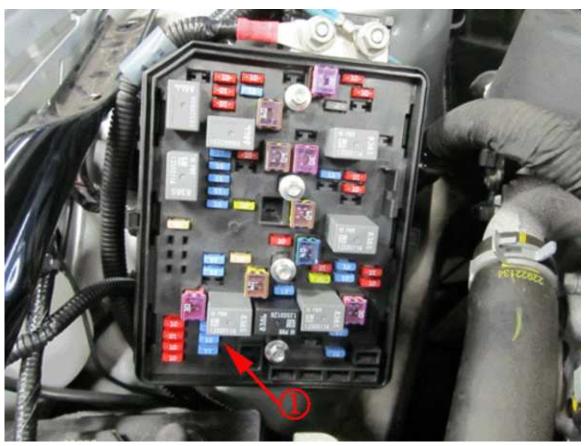
3. Pull 1 relay (1) and read the amps. Subtract original reading (16-18 amps) from total. (Which should be under 26 amps).

If either fan motor draws more than 26 amps, replace both fan motors. Refer to Engine Coolant Fan Motor Replacement in SI.

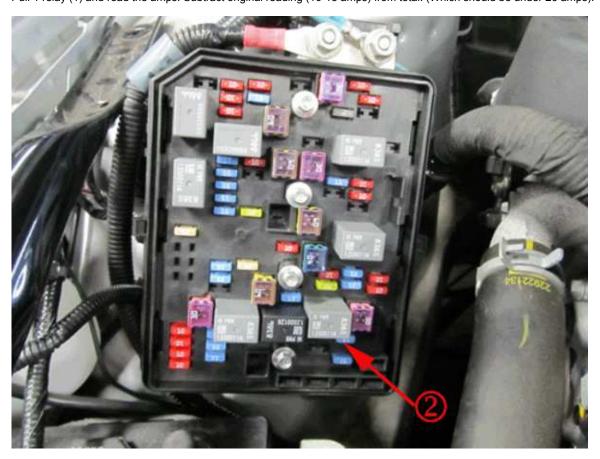
4. Reinstall the relay, pull the second relay (2) and repeat.
