Service Information Bulletin

SUBJECT	DATE
Symptom Diagnostics : Noisy 1- Box™ Aftertreatment	August 2016

2 Symptom Diagnostics: Noisy 1- Box Aftertreatment

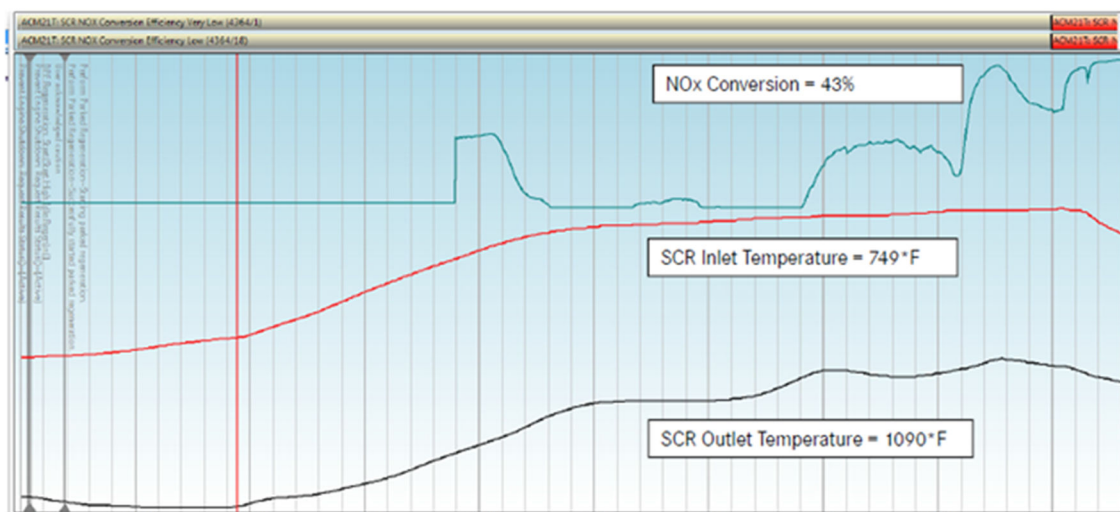
d500302

8. Review the last seven minutes of the parked regeneration log data. The illustration below identifies the last seven minutes of the parked regen.
9. Is the Selective Catalyst Reduction (SCR) inlet temperature lower than SCR outlet temperature by more than 38°C (68.4°F)?

Example : SCR Outlet temp (587°C) 1090°F minus SCR Inlet Temp (398°C) 749°F = (116°C) 241°F. The difference between inlet and outlet temperature is (116°C) 241°F, which is greater than (20.2°C) 68.4°F.

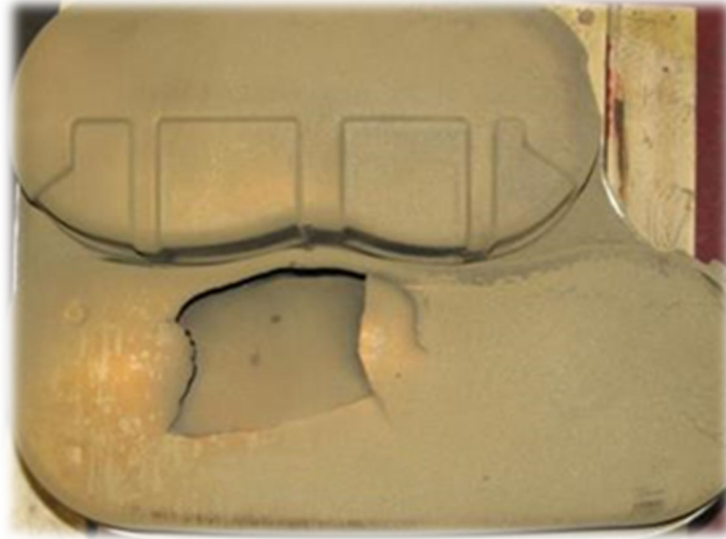
d500303

- a. Yes; Go to step 10.
 - b. No; Go to step 11. for log file review.
10. Perform a low temperature Aftertreatment Device (ATD) check using DiagnosticLink to check for a drifted temperature sensor. Are the SCR inlet and SCR outlet temperatures within 25°C (45°F) during the last five minutes of this test?
 - a. Yes; replace the DOC/SCR module. This indicates internal structural damage; see image below. The ATD checklist is NOT required since the ATD is the primary failed part.

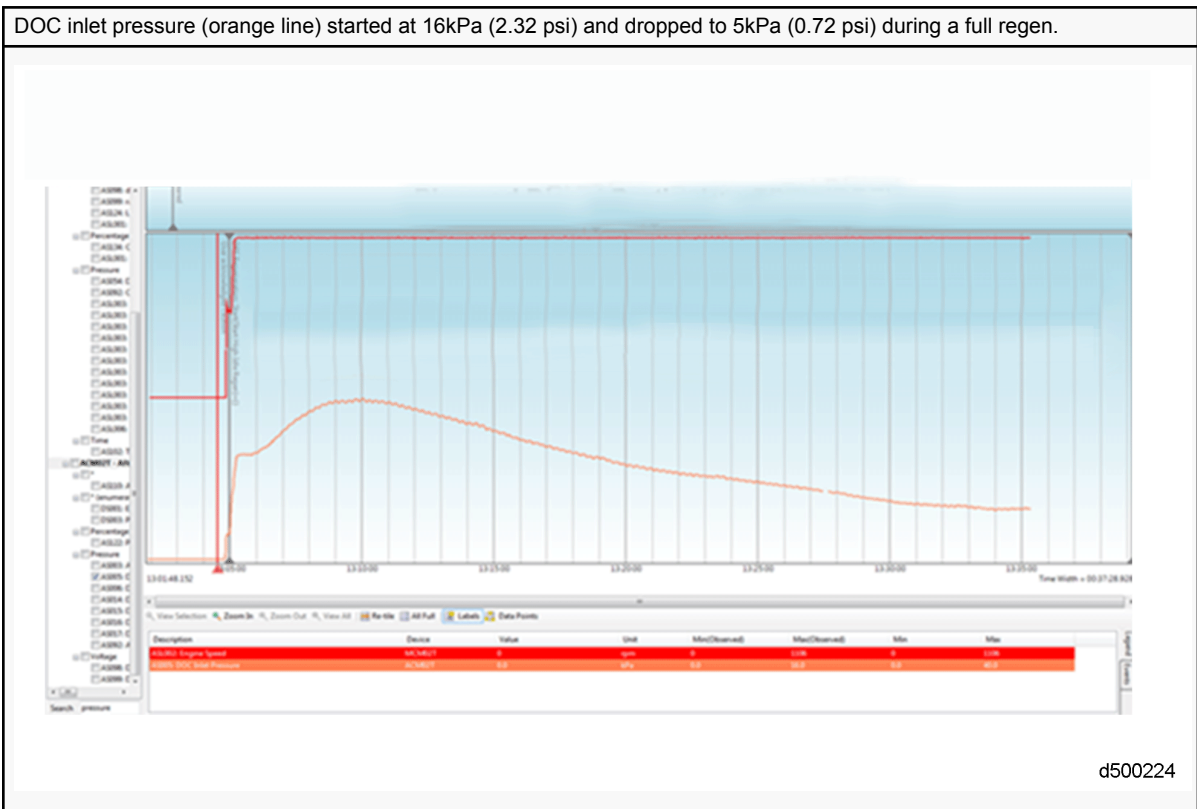
d500224

- b. No; replace the drifted SCR temperature sensor and Go to step 11.
- 11. Review the parked regen log file. Compare your DOC inlet pressure reading to the screen shots below (steps 12,13, and 14) to identify a possible cause of the aftertreatment noise.
- 12. Is the DOC Inlet Pressure starting out high above 10 kPa (1.45 psi) and decreases during a parked regen?
 - a. Yes; Go to step 15.
 - b. No; Go to step 13.

15. This indicates that the DPFs were plugged and the parked regen has cleared them. Verify the noise is gone and complete the ATD check list to possibly identify why the unit was plugged.
For EPA10: Refer to section "EPA10 Perform Performance Check - Low Temperature ATD"
For GHG14: Refer to section "GHG14 Perform Performance Check - Low Temperature ATD"

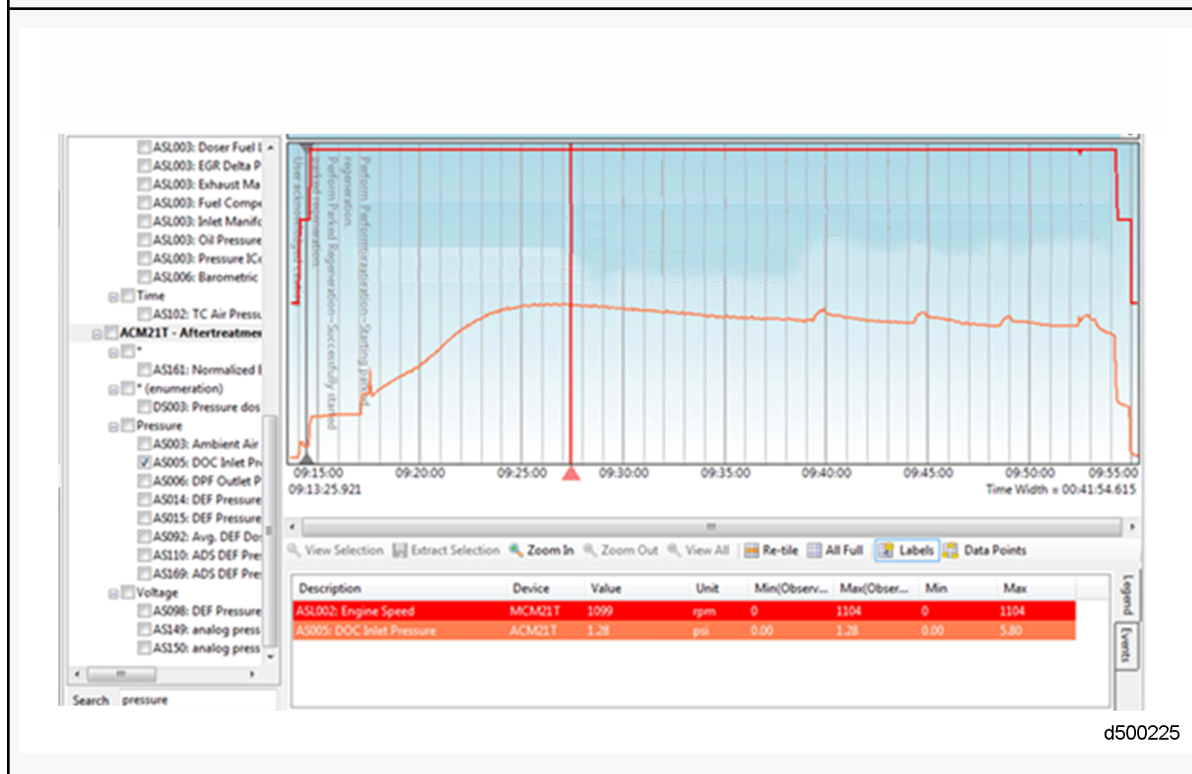
Table 3.

- 13. Is the DOC inlet pressure starting above the pressure specified below and stays high?

DOC inlet pressure (orange line) started at 6 kPa (0.87 psi) and stayed there throughout the regen. The slight spikes seen in the pressure reading are due to the fan turning on/off.

16. The DOC is considered plugged. Since the DOC inlet pressure stayed steady and there is still a noise, run the DOC Face Unplugging procedure in DiagnosticLink under Actions-Aftertreatment. Refer to section "EPA10 and GHG14 Diesel Oxidation Catalyst Face Cleaning". After completing the service routine, verify the noise is gone. Go to step 17.

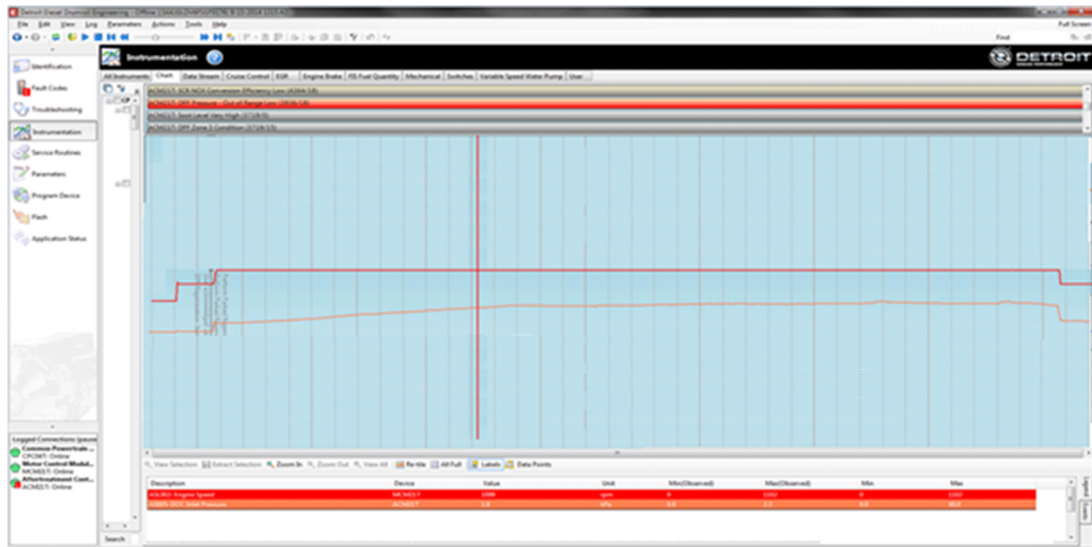
d500226

- Is the DOC inlet pressure starting out **low** and staying **low**, below 3.1 kPa (.45 psi)?
 - Yes; The Aftertreatment System (ATS) is considered noisy. Replace the DOC/SCR module. This indicates internal structural damage; see image below. The ATD checklist is **NOT** required since the ATD is the primary failed part. Verify repair. Go to step 17.
 - No; The Aftertreatment System (ATS) is considered noisy. Replace the DOC/SCR module. This indicates internal structural damage; see image below. The ATD checklist is **NOT** required since the ATD is the primary failed part. Verify repair. Go to step 17.

DOC inlet pressure (orange line) starts out low and stays low, below 10 KPa (1.45 psi) the ATS is considered noisy. The noise may be more present between 7 to 9 KPa (1.01 psi – 1.30 psi).
