August 2016
FL711A-D
NHTSA #16V-321

Subject: Motorhome Throttle Pedal Return

Models Affected: Specific Freightliner Custom Chassis XCL, XCM, XCP, and XCR chassis manufactured January 23, 2012, through April 10, 2014, and equipped with certain Williams Control throttle pedal assemblies.

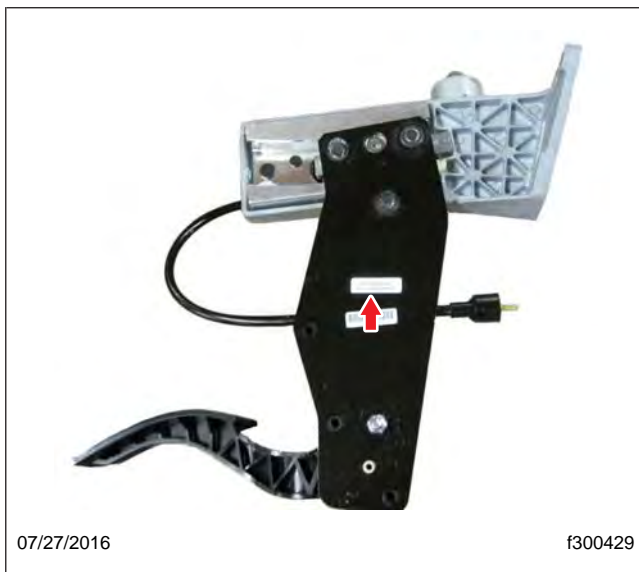
Fig. 1, Location of the Throttle Pedal Identification Label

3. Inspect the throttle pedal identification label, shown in [Fig. 1](#). Each label has a serial number, shown in [Fig. 2](#), which indicates the manufacture date. In this example, the manufacture date 160725 of the throttle pedal is July 25, 2016.

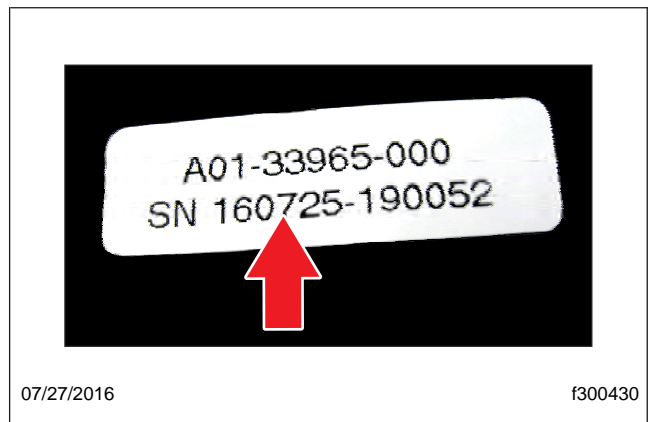
Fig. 2, Throttle Pedal Serial Number

If the manufacture date is March 18, 2014, or later, no further work is needed. Go to step 10.

If the manufacture date is before March 18, 2014, continue with the next step to replace the throttle pedal.

4. Remove the hardware that attaches the throttle pedal assembly to the firewall.
5. Remove the throttle pedal assembly. Continue holding the throttle pedal for the next step.

6. Disconnect the electrical connectors and the adjustable pedal cable from the throttle pedal assembly.
7. Discard the throttle pedal assembly.
8. Connect the adjustable pedal cable to the new throttle pedal assembly and connect the electrical connectors.
9. Using new hardware, install the throttle pedal assembly. Tighten 13 lbf-ft (18 N·m).
10. Clean a spot on the base label (Form WAR259). Write the recall number, FL711, on a completion sticker (Form WAR260), and attach it to the base label.
