Front Radar, Reprogramming
CHU, CXU

FSB 366-003, Front Radar, Reprogramming

(July 2016)

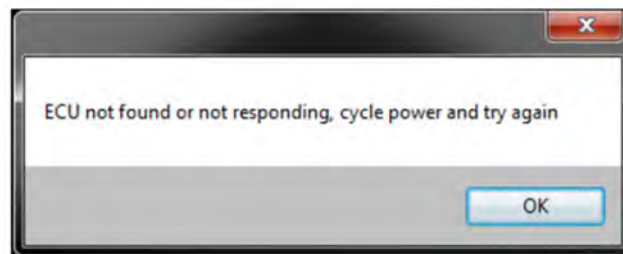
W3113800

10 All other choices will cause the following error message below to display.

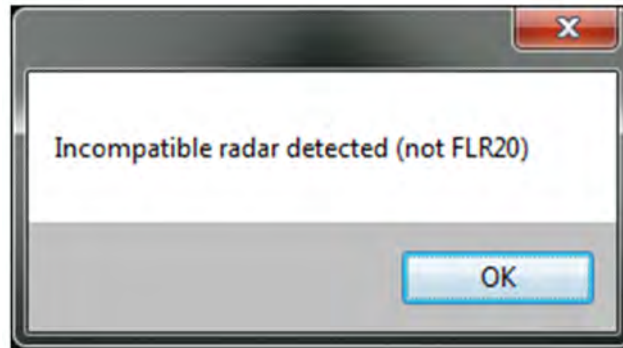
W3113805

15 If this reprogramming is completed on a truck built with the incorrect front radar, the following error message below will display.
