Service Bulletin

Subject: Diagnostic Tip - Oil Leak From Crankshaft Rear Oil Seal

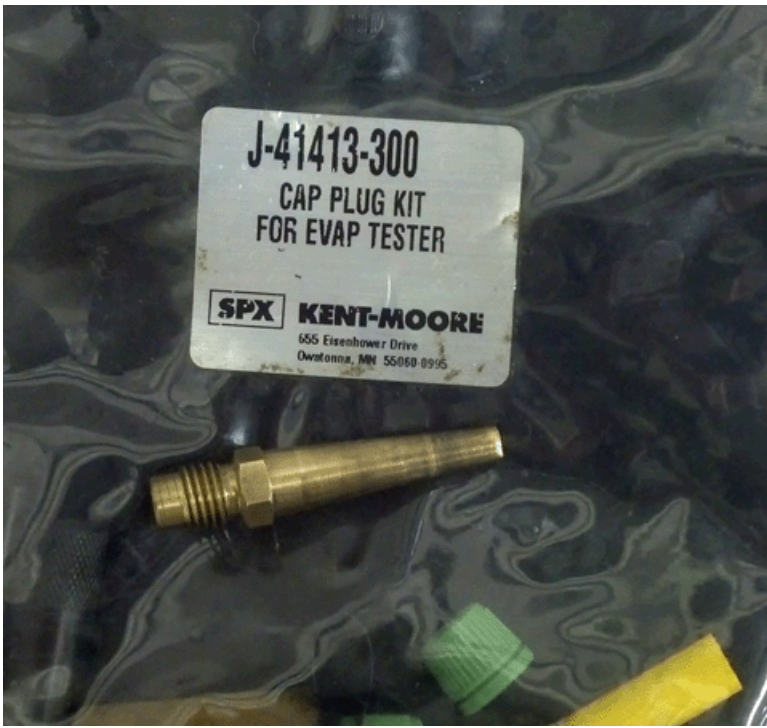
EEST hose adaptor.

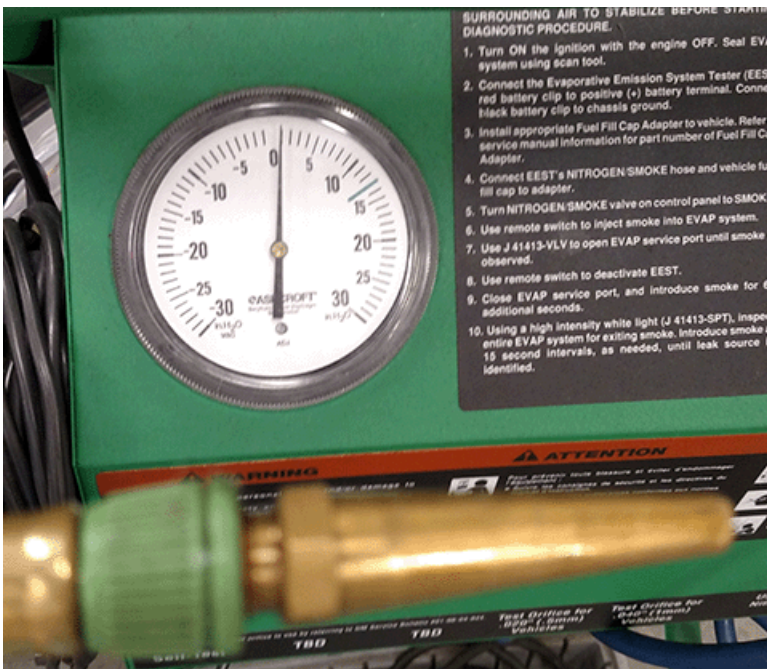
EEST Gage at 0 reading.

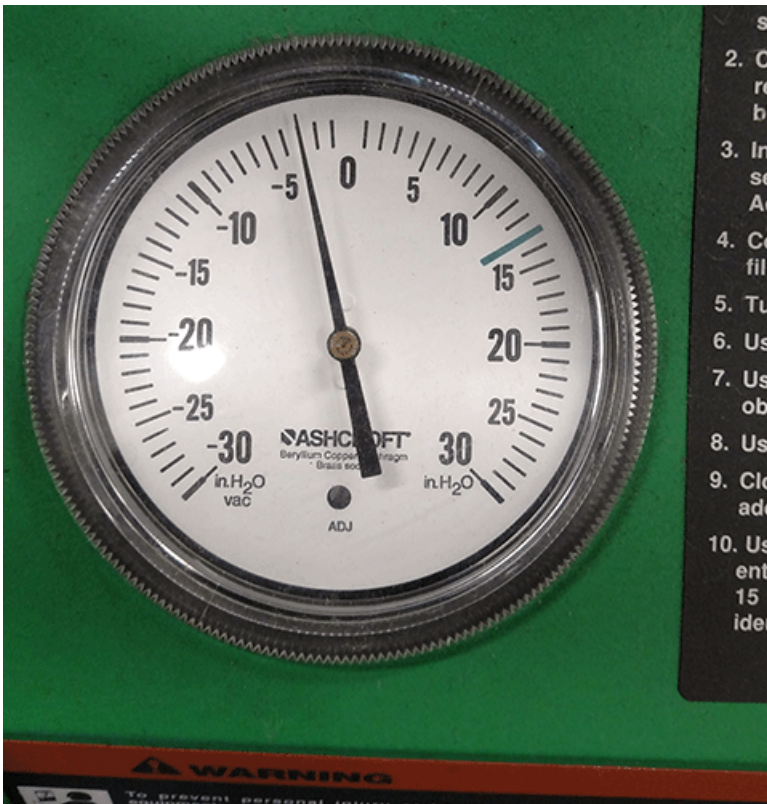
Normal crankcase pressure readings for the LE2 and LFV are between -1 & -5 inches of water in park at hot idle.

Normal crankcase pressure readings for the L3A, LE2 and LFV.

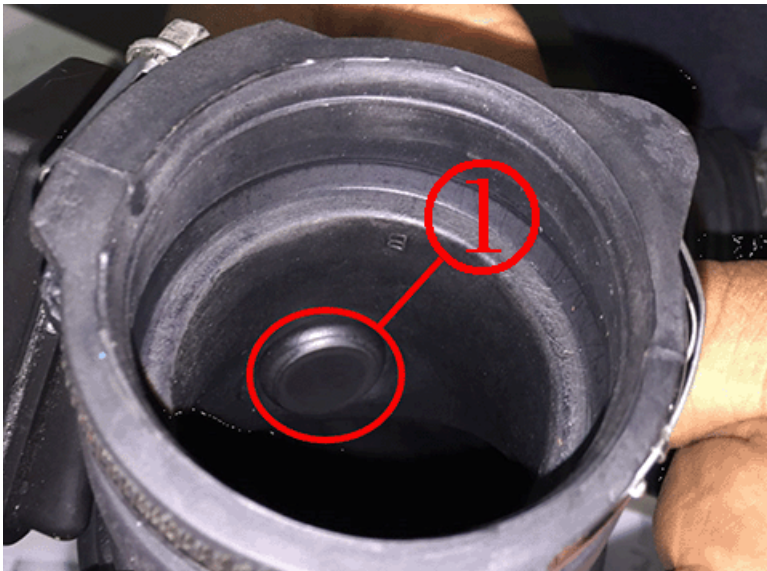
If the crankcase pressure is excessively negative, below -16 inches of water (-1 inches of HG / vacuum) then a negative crankcase pressure concern exists requiring further diagnostics.

Inspect the Air Cleaner Outlet Duct for a blocked PCV fresh air port. (See picture below)

Air Cleaner Housing Outlet Duct with port closed causing excessive negative crankcase pressure.

If the port is not blocked, then replace the camshaft cover assembly and retest for proper crankcase pressure.
