Bulletin No.: PIP5418

PRELIMINARY INFORMATION

Subject: Rattle Noise From Engine Area While Driving

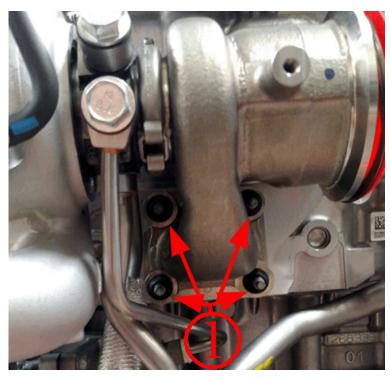
Involved Region or Country	North America				
Additional RPO/s	N/A				
Condition	Rattle noise from turbocharger off idle				
Cause	Rattle noise coming from the turbocharger wastegate actuator rod

To isolate the noise to the turbocharger wastegate actuator rod apply a small amount of pressure to the wastegate rod using a suitable tool while the condition is present.

If bolt torque is correct and the noise has been isolated to the turbocharger wastegate actuator rod, do not replace any components at this time as GM Powertrain is aware of this condition and reviewing options.
