Service Bulletin

PRELIMINARY INFORMATION

Subject: During PDI Front Wheel Opening Molding Pushpin Installation

Models: 2015-2017 Cadillac Escalade Models

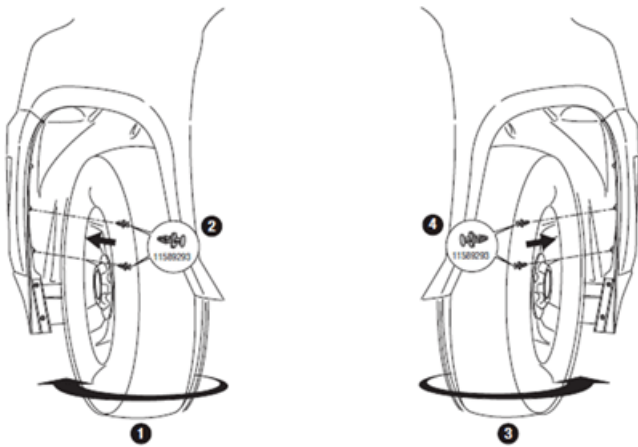
During the PDI the front wheel opening molding pushpins will need to be installed. Reference photo below.

Note: These pushpins with instructions will be shipped with the truck, see below.
