Service Bulletin

Subject: Installation Tip - Door Striker Cover Installation During PDI

Models: 2015-2017 Cadillac Escalade Models
2015-2017 Chevrolet Tahoe LTZ, Suburban LTZ
2015-2017 GMC Yukon Denali Models

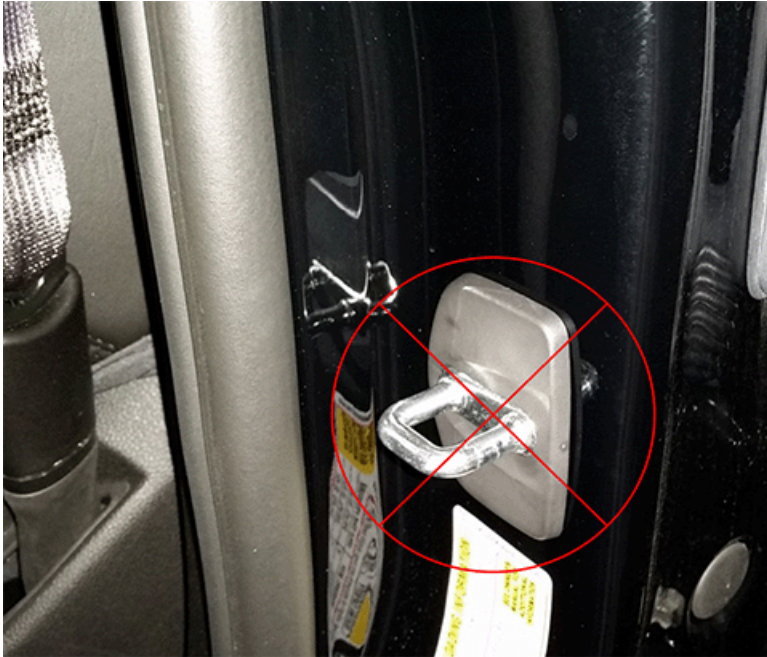
There have been reports of these covers being installed incorrectly / backwards, as shown below.
