# Service Bulletin

**Subject:** Remote Start Inoperative / Power Liftgate Inoperative And/Or DTC P2537 / Blower Motor Stays On With Ignition Off

**Models:** 2015-2017 Cadillac Escalade Models  
2014 Chevrolet Silverado 1500  
2015-2017 Chevrolet Silverado, Suburban, Tahoe  
2014 GMC Sierra 1500  
2015-2017 GMC Sierra, Yukon Models

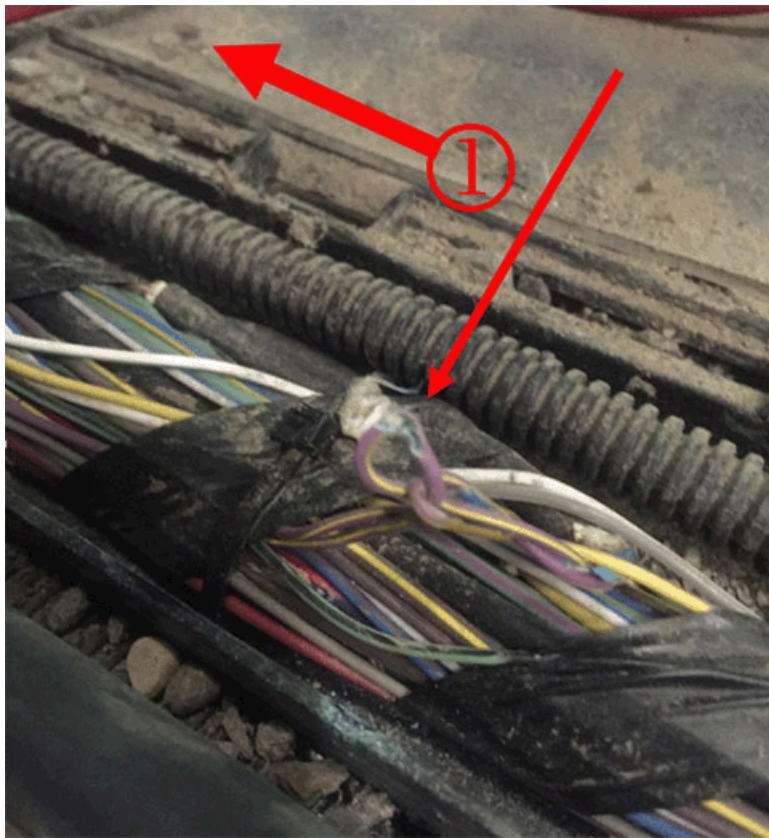
These concerns may be caused by the ECM and/or TCM not receiving the 12 volt accessory wakeup signal from the BCM. Reference the accessory wake up circuit 5985 wiring diagrams in SI under Power and Signal Distribution/ Data Communications/ Schematic and Routing Diagrams/ Data Communication Schematics/ Accessory Wakeup and Communications Enable.

One known area for high resistance/open in circuit 5985 is under the driver's sill plate, as shown below. Call out 1 indicates the front of the vehicle.

Using a voltmeter, check circuit 5985 at the ECM and TCM. There should be approximately battery voltage present with the ignition on. You may notice after the ignition has been turned off, there is still voltage present. This is because the BCM may still be awake. This should be considered normal. If no or low voltage is found, use the wiring diagram in SI and perform normal circuit diagnosis.

For wiring repairs covered under warranty, please refer to latest version of bulletin 10-00-89-005 for warranty information on wire/connector repairs.
