# Service Bulletin

## PRELIMINARY INFORMATION

**Subject:** Radio Back Lighting Stays On After Key Off / Dead Battery / TCCM Repeat Failure

**Models:** 2014 Chevrolet Silverado 1500  
2015-2017 Chevrolet Silverado  
2014 GMC Sierra 1500  
2015-2017 GMC Sierra  
With Transfer Case (RPO NQF or NQH)

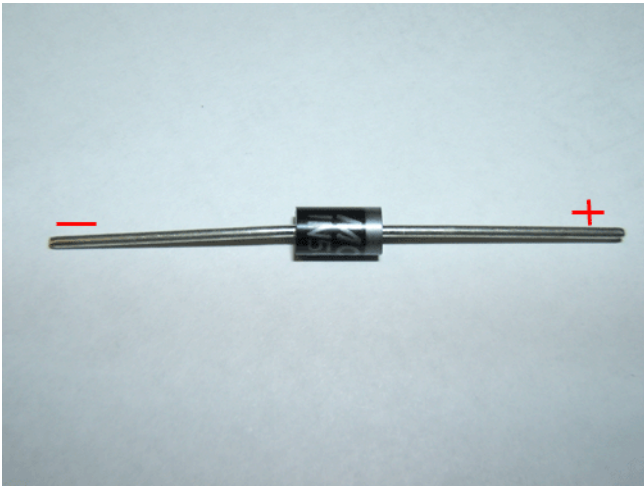
To prevent damage to any of the sensitive electronic components on the bussed circuit, the solenoid/relay MUST have the control circuit suppressed with a diode. The diode will prevent the voltage spikes from being transmitted onto the Run/Crank circuit.

Install a diode, P/N 12112422, across the coil of the solenoid. It is important that the striped end of the diode be connected to the positive terminal of the coil and the other end of the diode be connected to ground.
