Service Bulletin

PRELIMINARY INFORMATION

Subject: No Crank / Start Then Immediate Stall / SES MIL / Service 4WD / Relay Clicking / Rearview Camera Inop / DTC (Inspect Ignition 1 voltage)

Models: 2015-2016 Cadillac Escalade Models
2014 Chevrolet Silverado 1500
2015-2016 Chevrolet Silverado, Suburban, Tahoe
2014 GMC Sierra 1500
2015-2016 GMC Sierra, Yukon Models

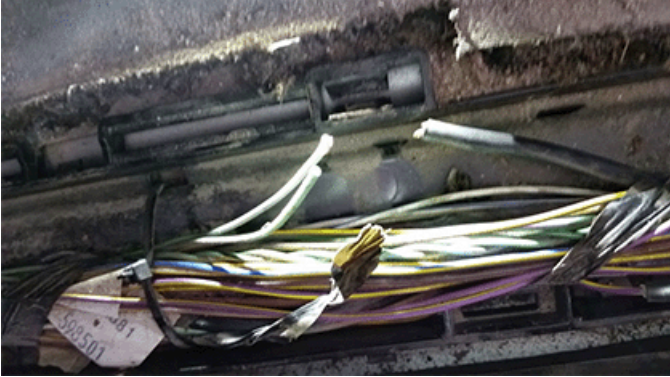
- Either or both KR73 Ignition Main Relays not turning on to provide power to their respectable fuses.
- Terminal issues at a fuse block connector where the Ignition 1 circuits exit the fuse block, example Document ID: 4232460, circuit 439 at the Underhood Fuse Block connector X2 terminal M7. In these situations, the KR73 Ignition Main Relays are turning on and providing power to their respective Ignition 1 fuses, but there will be no Ignition 1 power to their respective module/component, due to the terminal issue at the fuse block.

- Terminal M5 at connector X4, for circuit 5199
 - Terminal M7 at connector X2 for circuit 439
2. Inspect for any backed out terminals, poor terminal fit and/or bent/twisted terminals at the Left I/P Fuse Block-X51L.
The most common terminals with these issues have been:
- Terminal 42 at connector X1, for circuit 5199
 - Terminal 44 at connector X2, for circuit 1850
3. Circuit 5199 under the driver's sill plate for being damaged/corroded, as shown below.

Repair any wiring / terminal issues using the appropriate SI wiring repair documentation.
