## CCV Housing Inlet Tube, Replacement MP7 US14, US15 CXU, GU LEU, LR, MRU

### FSB 257-004, CCV Housing Inlet Tube, Replacement

(June 2016)

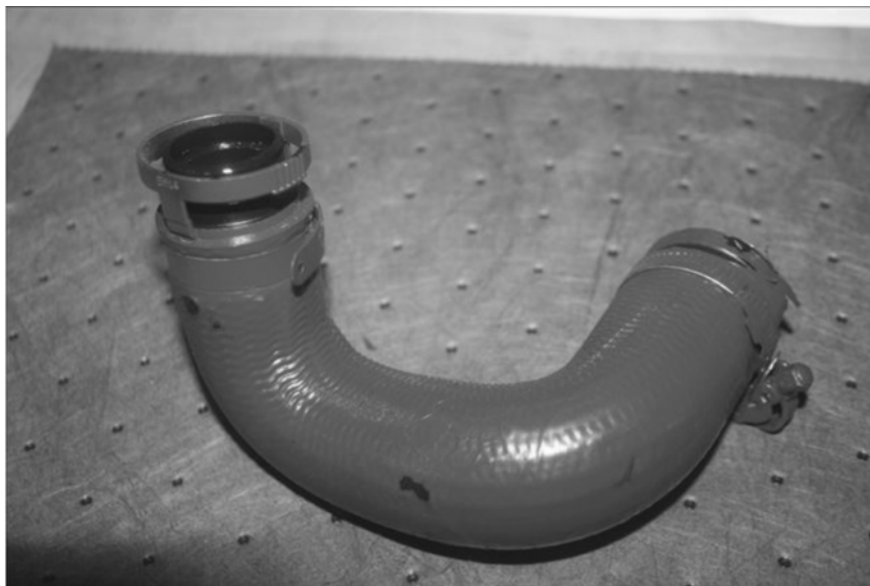
W2111722

MACK Trucks has received reports from the aftermarket regarding oil leaks at the CCV housing inlet tube and at the split line between the upper and lower housings on chassis builds between January 1, 2014 and January 26, 2016 with MP7 engines. It has been determined that the O-ring installed on the inlet tube is the source of the leak and oil may leak down the back of the housing giving the impression that the housing split line is also leaking.

Should there be a report of this nature on a chassis built within the affected date range, do not disassemble the CCV. Replace the inlet tube with part number 22858726. Clean the surrounding area to complete the repair. If it is determined that there is a leak at the housing other than the inlet O-ring, the complete CCV assembly will need to be replaced as this is a non-serviceable part. Do not attempt to tighten the split line screws on the housing or disassemble the assembly as seals and repair parts are no longer available for this component as they were on the older version of this component. If the collar on the CCV inlet is worn or broken at the locking lip, replace the complete CCV assembly.
