# Service Bulletin

**Subject:** Water Leak Into Rear Floor

**Models:** 2010 - 2015 Chevrolet Camaro  
Both Coupe and Convertible Models

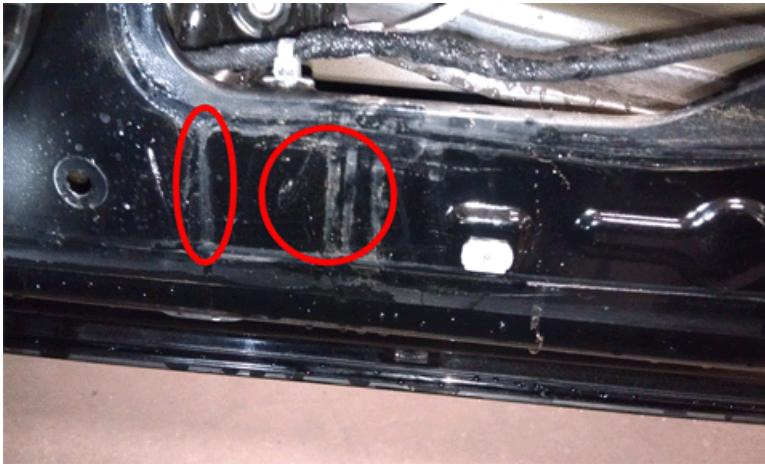
Water may pool into the rear floor pan on either the driver or passenger side. This condition could occur on either the coupe or convertible body style and should be inspected for prior to performing other repairs.

Water test the vehicle to duplicate the condition. Remove the door trim panel of the affected side of the vehicle to inspect for water pooling in or leaking from the door water deflector. If water is pooling between the door and water deflector or is leaking past the water deflector then carefully remove the water deflector. Reseal it to the door using a butyl rope such as 3M Strip-Calk\*, or equivalent, to eliminate the possibility for pooling or leaking.
