03346 Version 3

Product Update: 2006 Ridgeline Inner Door Handle Cable End Clip

(Supersedes 06-012, dated April 29, 2016, to revise the information highlighted in yellow.)

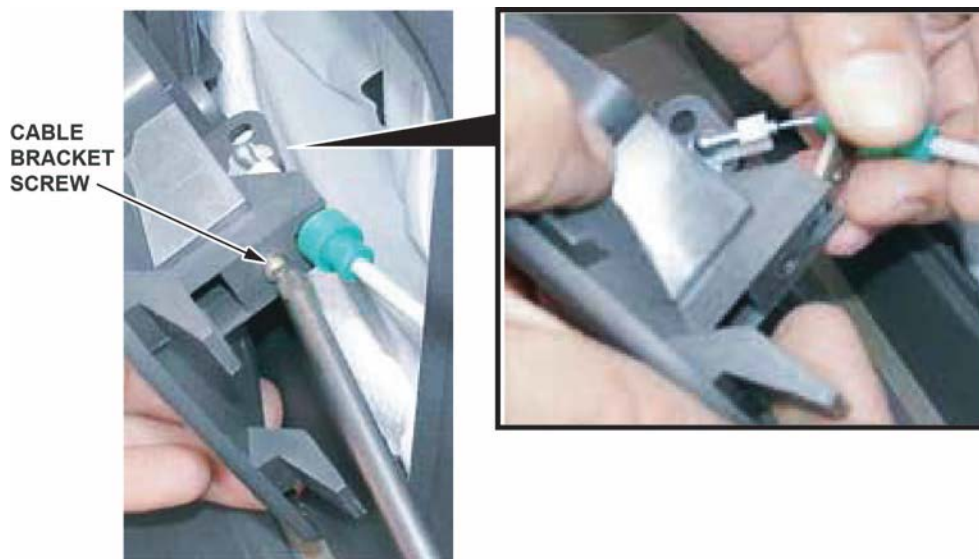
1. Remove the inner door handle. Refer to the service information.
2. Remove the cable bracket screw and detach the inner handle cable from the inner handle (right rear inner handle is shown).

Replace the inner door handle on all four doors.

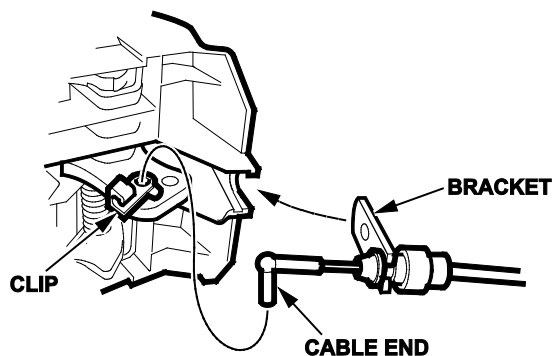
3. Separate the cable end from the clip (snap).

4. Install the cable end into the new handle and secure the clip to the cable end.
5. Reinstall all parts in reverse order of removal.
6. Repeat steps 1 through 5 for the remaining three doors.
