# Service Bulletin

16-031

# Power Tailgate Won't Open from the Outside in Cold Weather

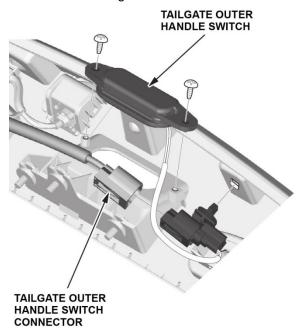
The power tailgate outer handle switch is inoperative in cold weather.

- 1. Remove the rear license trim.
- 2. Disconnect the tailgate outer handle switch connector.

- 3. Remove the tailgate outer handle switch.
- 4. Install the new tailgate outer handle switch.
- 5. Connect the connector.
- 6. Install the rear license trim.
