Document ID: IK1100031

Title: Hard to Crank Condition on ProStar, LoneStar, and TranStar Vehicles

Applies To: ProStar, LoneStar, and TranStar Vehicles with Hydraulic Clutch Linkage and Solo Clutch

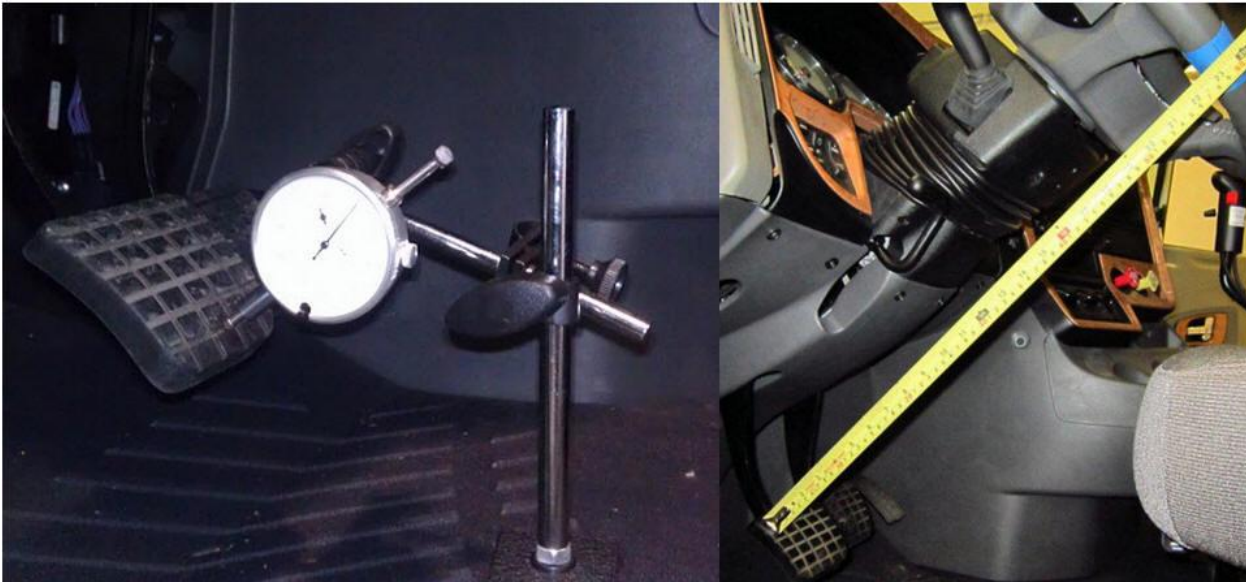
If the clutch release pedal requires excessive effort to allow the vehicle to crank after replacing the clutch switch, then check the clutch release pedal free travel. If the pedal is from 0.700" to 0.800", then move on to the next step. If the pedal is less than 0.700", then increase the free play to 0.700"-0.800".

- Preferred Procedure- Use a dial indicator to measure the free play adjustment. When setting up the dial indicator, adjust the indicator so the needle does not slide across the pedal, but follows the pedal. This is the most accurate way to measure the clutch release pedal free play, and will allow the final adjustment point to be set accurately.
- Alternate Procedure- This should only be done if a dial indicator is not available. Using the tilt function on the steering column, align the steering wheel to the clutch release bearing travel position. Use a piece of masking tape and wrap the steering wheel in line with the clutch release pedal. Mark a line on the masking tape and measure from the pedal to the line at the top of the pedal range and at the bottom of the free play range. Using the tape measure, adjust the clutch release pedal free play to 3/4".

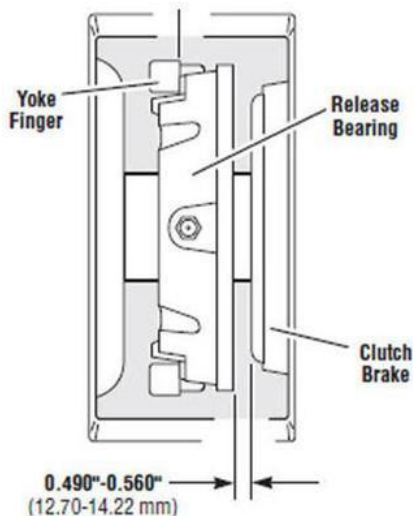
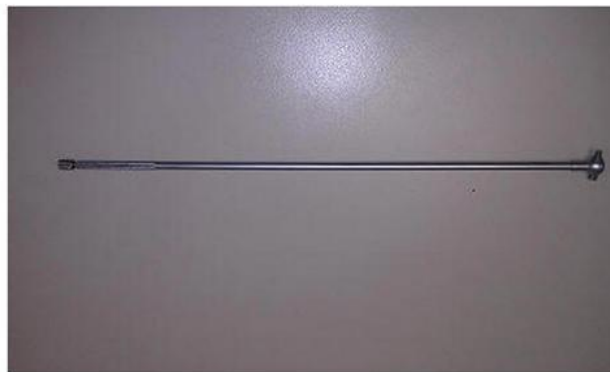
Remove the clutch inspection cover, and measure the bearing to brake position. Inserting a bar that is about 0.500" is NOT an acceptable procedure for checking the clutch bearing to brake measurement.

- Preferred Procedure- Use a telescoping gage or inside caliper capable of a 0.400" - 0.600" range, and insert it between the clutch bearing and the clutch brake aligned with the center of the brake and the center of the bearing. Then measure the gage using a micrometer or a dial/digital caliper.
- Alternate Procedure- Use a feeler gage set (shim stack), and stack the correct number and size feeler gages to allow the feeler gage stack to fit snugly between the clutch bearing and brake. Then measure the feeler gage stack using a micrometer or a dial/digital caliper.
