Document ID: IK1200909

Title: Complete High Pressure Turbocharger Replacement Guidelines for MaxxFo[®] 11/13, 15L and N13 Engines

Applies To: 2010 MaxxFo[®] 11/13/15 and N13 Engines

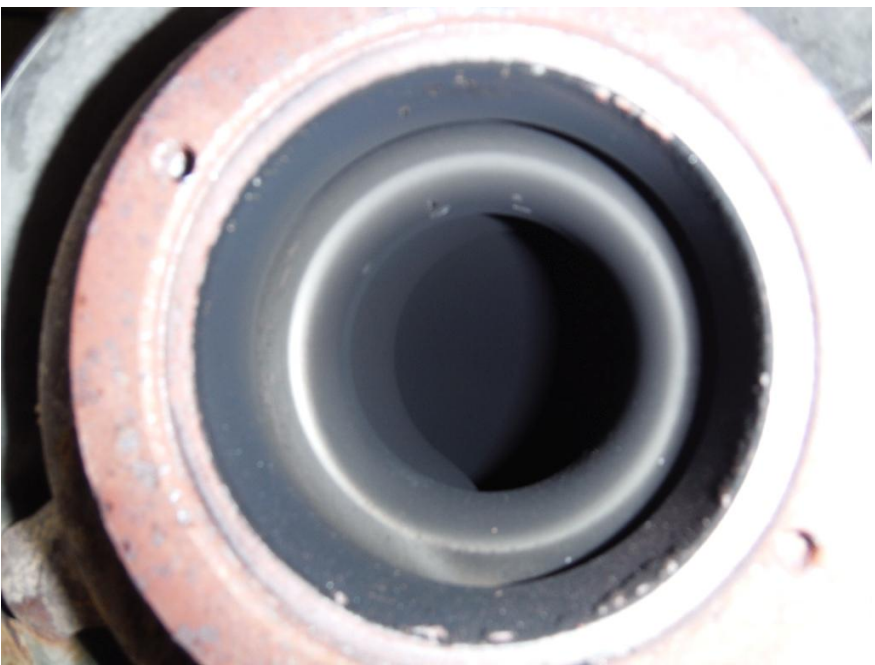
<p>Minor damage to the Turbine housing (Exhaust Side) of High Pressure Turbo. Reference Special Requirement for proper cleaning and replacement procedure.</p>
	<p>Small nick's in the Turbine (Exhaust Side) Housing of the HP Turbo. Reference Special Requirement at the bottom of the page for proper cleaning and replacement procedure.</p>

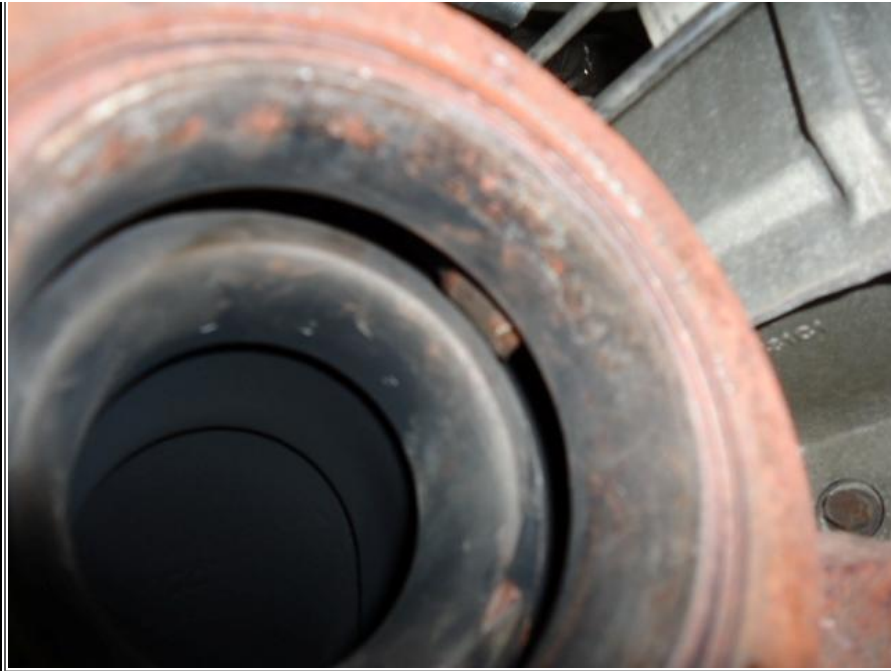
Major Damage to Turbine (Exhaust Side) Housing of the High Pressure Turbo. Turbo is recommended to be replaced as an assembly.

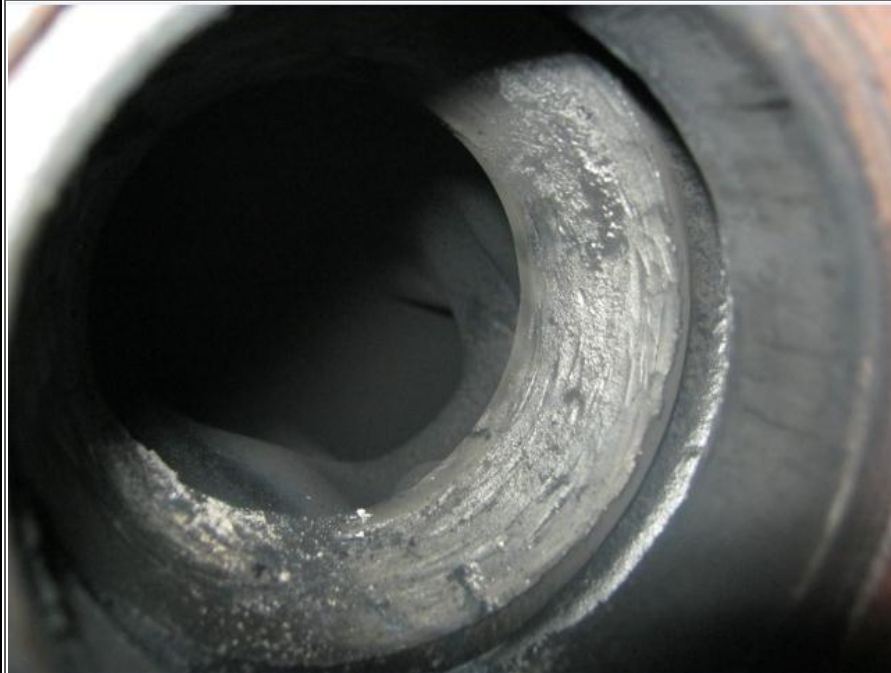
Damage to Turbine (Exhaust Side) Housing of HP Turbo. Turbine housing will need to be cleaned.

Special Requirement at the bottom of the page for proper cleaning and replacement procedure.

Once clean of all soot reevaluate damage to HP Turbo. If major Damage to Turbine Housing of the High Pressure Turbo is found after cleaning. Turbo is recommended to be replaced as an assembly.

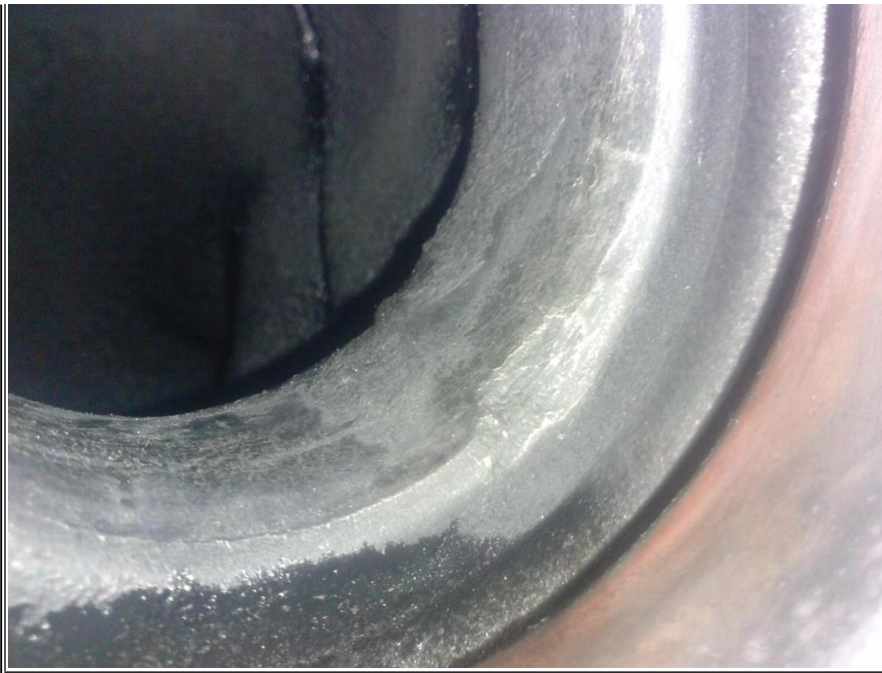
Major Damage to Turbine (Exhaust Side) Housing of the High Pressure Turbo. Turbo is recommended to be replaced as an assembly.

Removal of the wastegate has resulted in broken bolts on the turbine (Exhaust) housing.

Turbo is recommended to be replaced as an assembly.

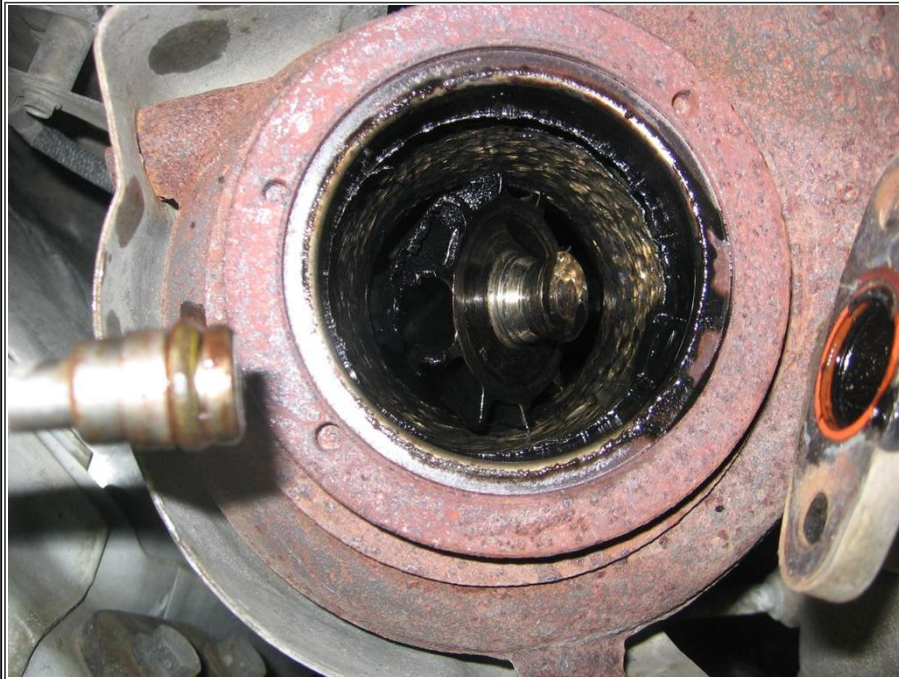
A binding or sticking wastegate is found.

Turbo is recommended to be replaced as an assembly.
