Service Bulletin

PRELIMINARY INFORMATION

Subject: Rattle Noise Diagnostics with LWN 2.8L Diesel

Models: 2016 Chevrolet Colorado
2016 GMC Canyon
W/ LWN 2.8L Diesel Engine

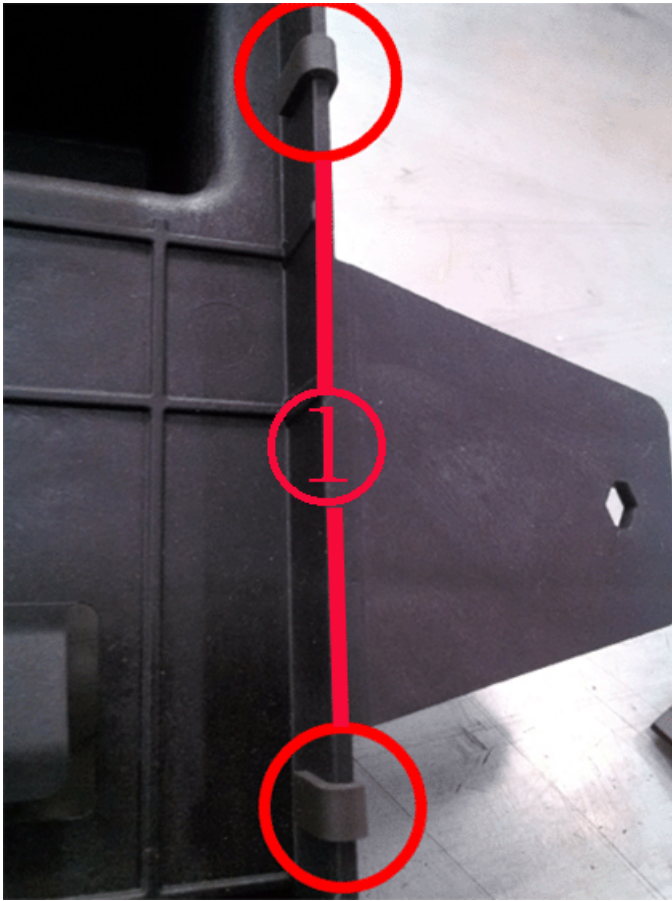
The customer may state there is a rattle noise that seems to come from the IP area.

1. The ECM may be loose in the mounting bracket. If you can move the ECM in the bracket remove it from the mount and apply 2 foam strips, 2mm thick, 20mm by 15mm to the body of the bracket and reinstall the ECM. (Recommend Walco 215 or 3M 4696 adhesive backed foam.) Place the foam strips as shown below.
