# Service Bulletin

**Subject:** (Malibu HEV) High Voltage Drive Motor Battery TAC Restriction and Exchange Program

**Models:** 2016-2017 Chevrolet Malibu Hybrid  
With RPO HP4

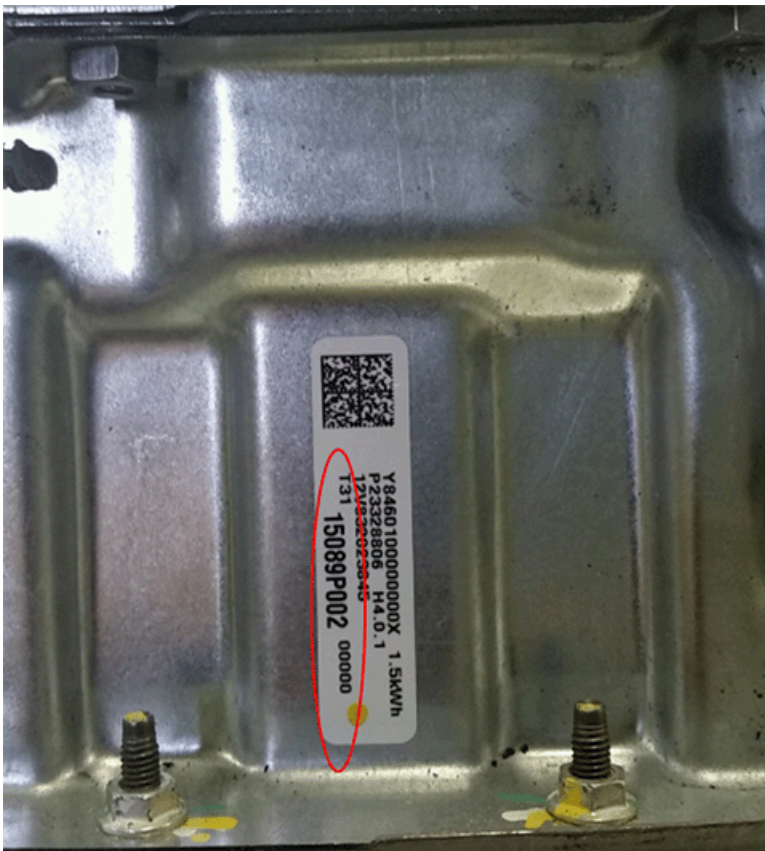
- 6.2 The battery has a battery identification tag that is located on the side of the battery. Locate the tag and record the 16 digit battery identification number (BIN). The BIN is the bottom most number on the label and it starts with a "T" indicator (See Photo Below). If the battery is not out of the vehicle yet, you can find the BIN by installing the MDI and using GDS 2. Access the Hybrid Powertrain Control Module 2 data list and look under the identification information section and the sixteen digit number will be listed under the parameter: Hybrid/EV Battery Pack Identification Number.
