May 17, 2016

01327 Version 2

## Clunk From Front Suspension When Driving at Low Speed Over Bumps or Turning

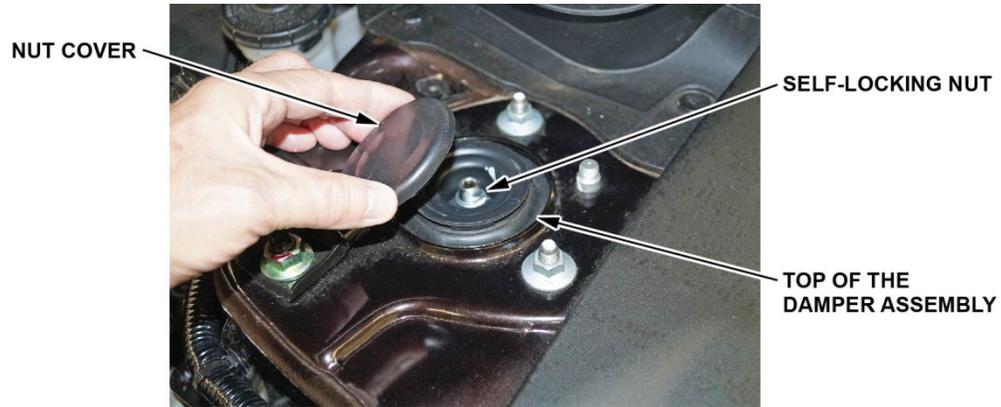
At least one of the self-locking nuts at the top of the front damper/spring assemblies is loose.

1. Remove the nut covers at the top of both front damper assemblies.
