**SERVICE PROGRAM BULLETIN**

**APPLICABILITY:** 2015 MY WRX 2.0L DIT Models  
 2014-2015 MY Forester 2.0L DIT Models

**SUBJECT:** Engine Control Module (ECM) Reprogramming

**NUMBER:** WQW-58R  
**DATE:** February 10, 2016  
**REVISED:** February 24, 2016

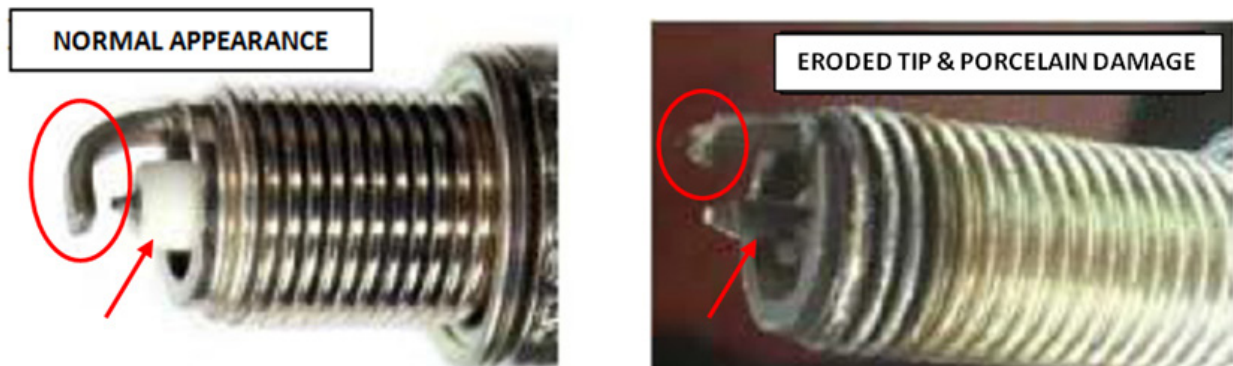
- **3-1:** Remove and inspect the spark plugs closely for any damage or excessive erosion. Inspect, rotate, turn upside-down and shake each spark plug to check for a cracked or loose porcelain insulator around the center electrode. Take note which cylinder(s) have spark plugs with verified damage and mark each plug, damaged or not, with the corresponding cylinder number.

**NOTE:** Any damage to the spark plug porcelain outside of the cylinder head is not a result of this condition.

- **4-1:** If the inspections performed in **Step 3-1** above revealed spark plug damage, the engine assembly must be replaced following the procedure in the applicable Service Manual. When complete, proceed to **Step 5** if reprogramming was determined to be necessary in **Step 1**. If no spark plug damage is found, proceed to **4-2**.
- **4-2:** If the inspections performed in **Step 3-2** above revealed high cylinder leak down percentages as described in the test equipment instructions or inconsistencies between cylinders, the engine assembly must be replaced following the procedure in the applicable Service Manual. When complete, proceed to **Step 5** if reprogramming was determined to be necessary in **Step 1**. If no leak-down inconsistencies were found, reinstall the spark plugs and proceed to **Step 5**.
