April 29, 2016

03346 Version 2

Product Update: 2006 Ridgeline Inner Door Handle Cable End Clip**(Supersedes 06-012, dated March 21, 2006; See REVISION SUMMARY)****AFFECTED VEHICLES**

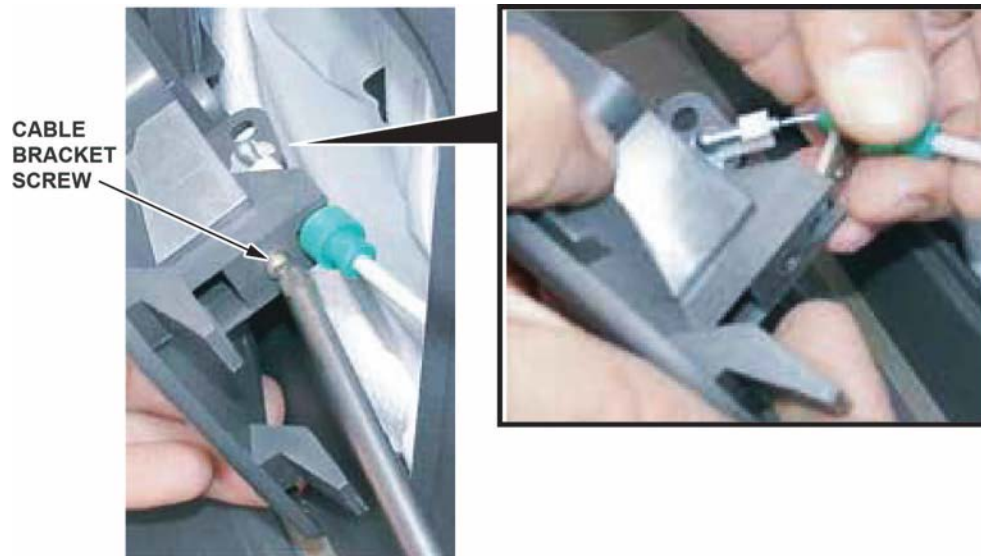
1. Remove the inner door handle. Refer to the service information.
2. Remove the cable bracket screw and detach the inner handle cable from the inner handle (right rear inner handle is shown).

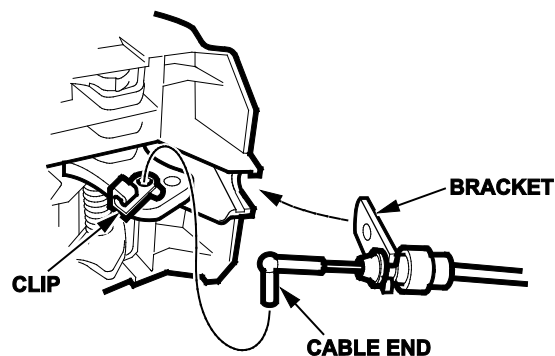
3. Separate the cable end from the clip (snap).

4. Install the cable end into the new handle and secure the clip to the cable end.
5. Reinstall all parts in reverse order of removal.
6. Repeat steps 1 through 5 for the remaining three doors.
