03969 Version 1

Creak From the B-pillar

AFFECTED VEHICLES

Year	Model	Trim	VIN Range
2014–15	Odyssey	ALL	ALL
2016	Odyssey	ALL	5FNRL....GB000001 thru 5FNRL....GB044289

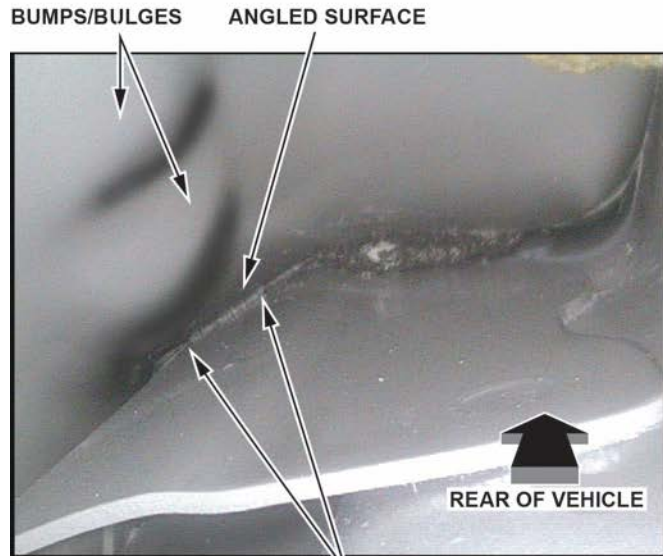
BORESCOPE VIEW INSIDE THE DRIVER'S SIDE B-PILLAR

The sheet metal has a touch point deep within the base of the B-pillar.

TOUCHPOINT BETWEEN THE TWO SHEETS OF METAL

13. Using a hammer and a small chisel, separate the sheet metal all along the touch points. Tap the chisel several times to obtain separation.

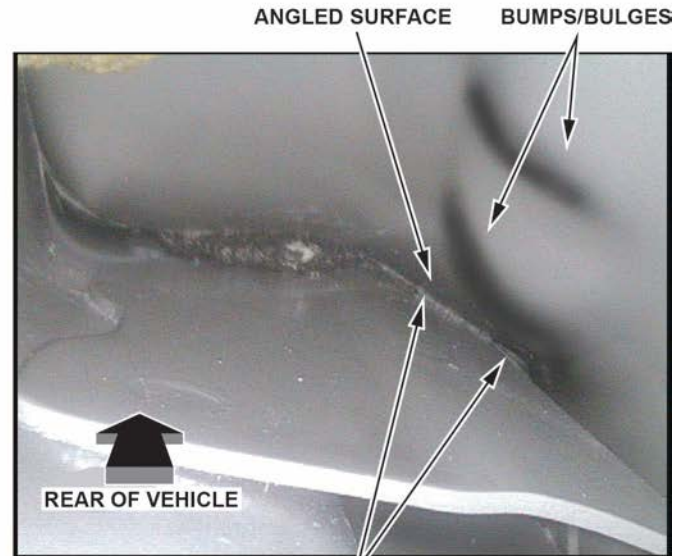
BORESCOPE VIEW INSIDE THE PASSENGER'S SIDE B-PILLAR

TOUCHPOINT BETWEEN THE TWO SHEETS OF METAL
