August 3, 2016

04492 Version 1

Product Update: 2015–16 Accord and 2015–16 CR-V DTC P1890**AFFECTED VEHICLES**

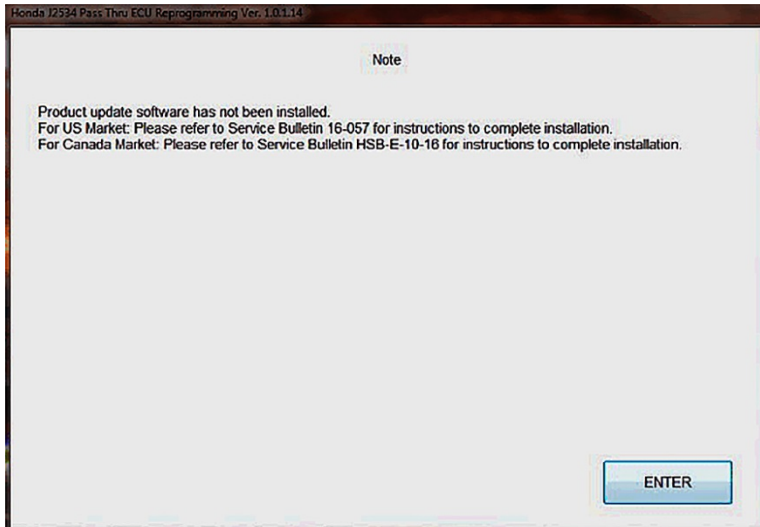
For 2015 CR-V's only: Depending on the current software in the PCM, you may see the following warning screen. If you do, go to S/B 16-057 to repair the vehicle.
