04086 Version 2

## Steering Wheel Noise When Driving

Supersedes 16-025, dated May 27, 2016, to revise the information highlighted in **yellow**.

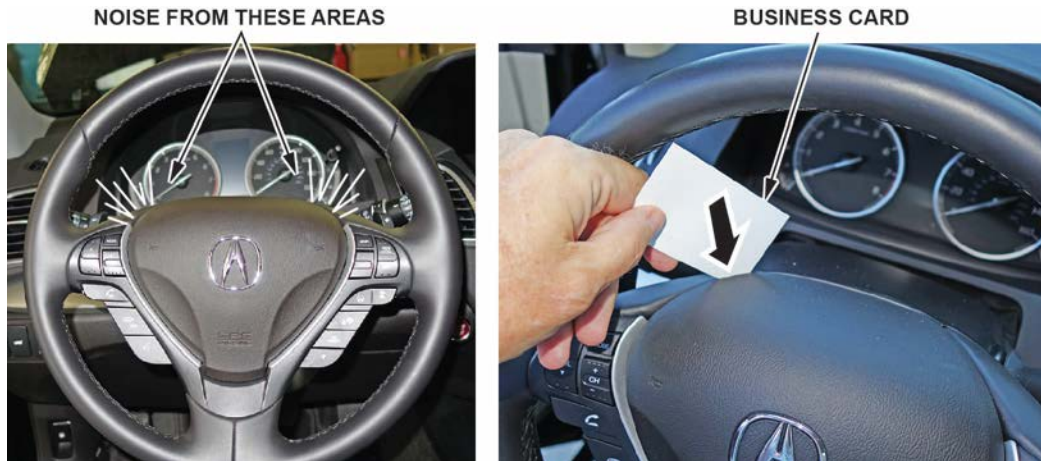
Drive the vehicle to confirm the source of the noise. Insert a **business card** or your finger, between the steering wheel spoke and airbag module on the side making the noise.

- If the noise stops or changes, continue to **REPAIR PROCEDURE**.
- If the noise does not change, this bulletin does not apply. Continue with normal troubleshooting.
