Service Alert No: 001310

Title: 2016-2017 CX-9 - THIRD ROW SEAT HEAD RESTRAINT IS NOT UPRIGHT

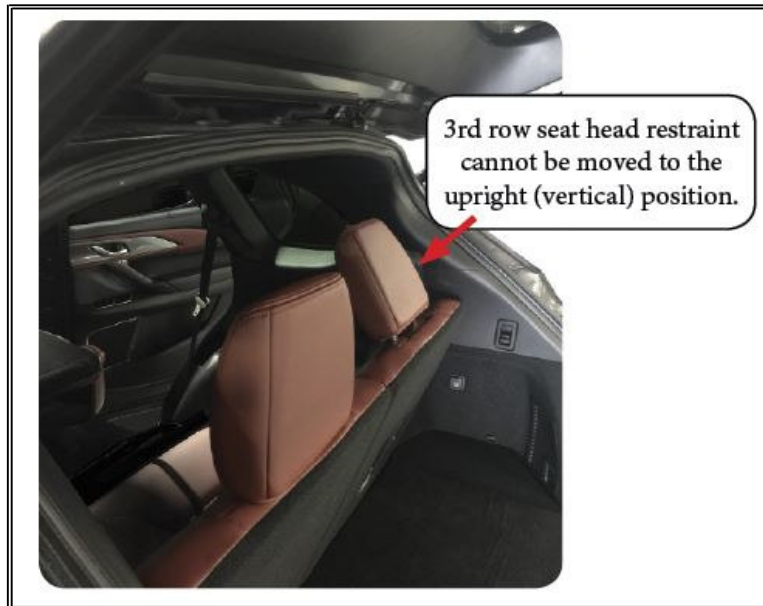
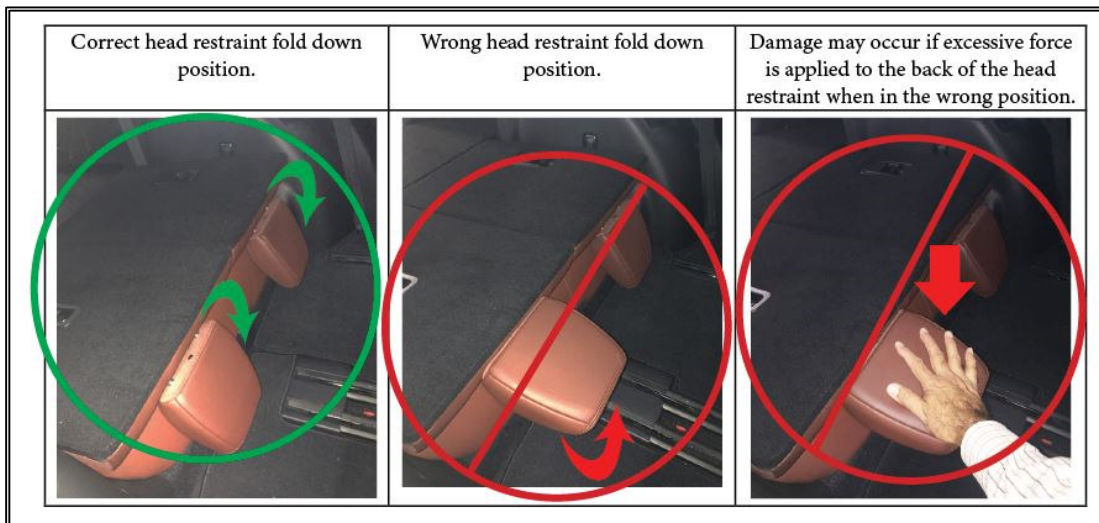
Some customers may complain about one or both third row seat head restraint(s) cannot be moved to the upright position. This may be caused by improper fold position of the head restraint(s) when the seat back is folded down.

Replace the third row seat back assembly.
