| <b>Subject:</b><br><b>DRIVER AND/OR PASSENGER SIDE FRONT SEAT CUSHION TRIM EDGE COMING OUT OF SIDE COVER - (LEATHER SEATS ONLY)</b> | <b>Bulletin No:</b> 09-043/16 |
| | <b>Last Issued:</b> 7/8/2016 |

2016 CX-9 vehicles equipped with leather interior with VINs lower than JM3TC\*\*\*\*\*107089 (produced before May 19, 2016)

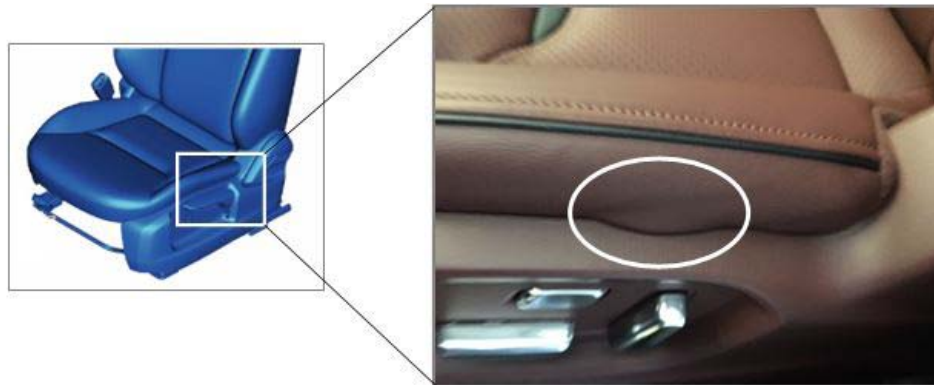
Some vehicles may exhibit the driver and/or passenger side seat cushion trim coming out of the side cover, causing a poor appearance concern. This is due to the seat trim edge being cut too short.

To eliminate this concern, the configuration of the seat trim will be improved.
