Subject: SCRATCH ON SEAT BACK BAR GARNISH FROM CONTACT WITH CONVERTIBLE TOP	Bulletin No: 09-018/16
	Last Issued: 07/14/2016

2016 MX-5 vehicles with VINs lower than JM1ND*****117680 (produced before May 16, 2016)

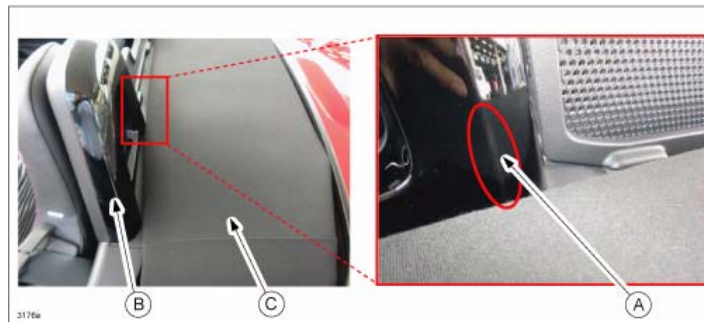
Some vehicles may exhibit scratches (A) on the rear of the seat back bar garnish (B) from contact with the convertible top (C).

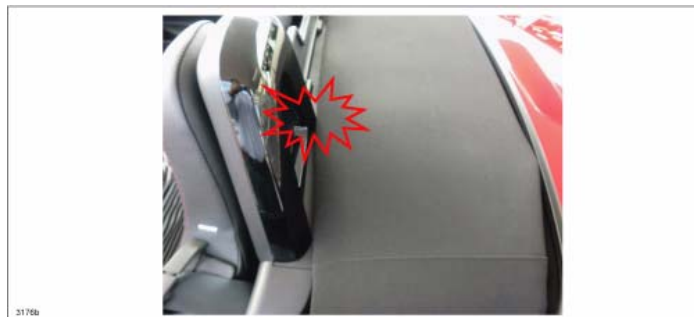
Due to assembly variations, the clearance between the seat back bar garnish and the convertible top is too small on some vehicles.

To correct the concern, the link stopper of convertible top has been changed to adjust the opening angle and folding position of the convertible top. This will increase the gap between the seat back bar garnish and the convertible top when folded down.

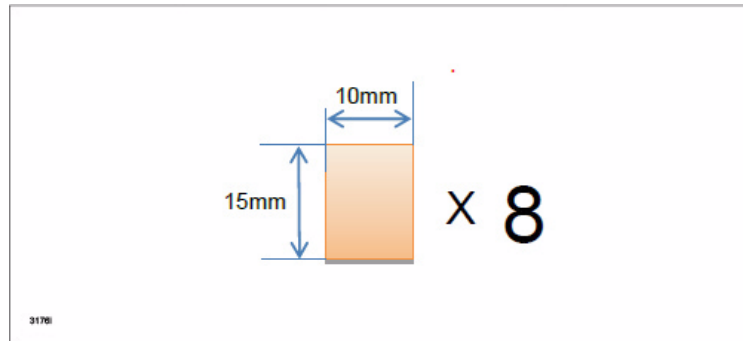
NOTE: The holes may be damaged when removing the metal fasteners of the back trim from the square holes of the seat back crossmember. A loose fit of these fasteners could cause a creak noise.

- a. Select a 0.25 mm thickness fabric sheet from the “Noise Repair Kit” (TA01-76-100) and cut out 8 equal squares 15mm x 10mm.
