Subject: MULTI-MODEL - KNOCKING / SQUEAKING NOISE FROM FRONT SHOCK ABSORBER, CREAKING NOISE FROM FRONT LOWER ARM BUSHING	Bulletin No: 02-010/16
	Last Issued: 07/21/2016

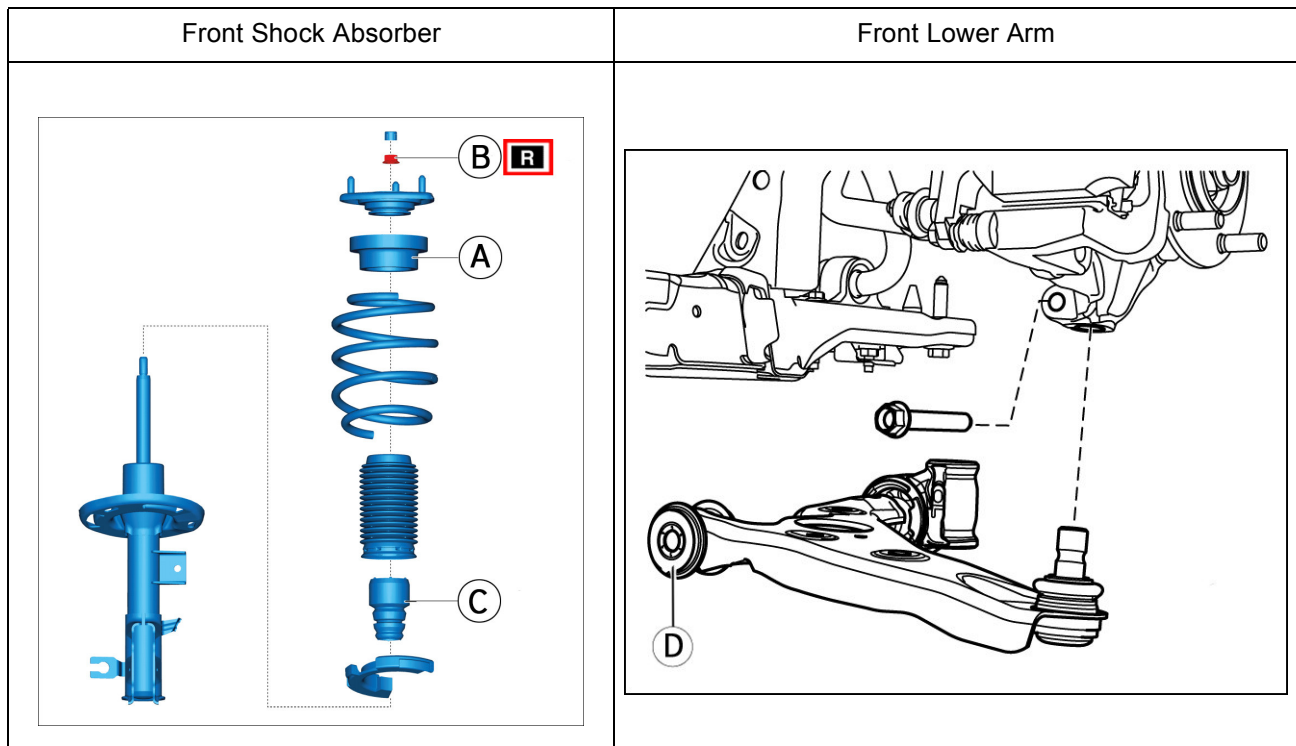
The noise may be due to:

- upper front strut bearing (A) damage. (CX-5 and Mazda6)
- stick/slip between the front strut bearing and coil spring. (CX-3, CX-5 and Mazda6)
- the bump stopper (C) may be contacting the strut bearing when the front shock absorber is compressed, causing a popping noise. (Mazda6 only)
- The front lower arm bushing (D) is making a stick-slip noise in wet road conditions. (CX-5 and Mazda6)

To eliminate the noise, the following mass-production changes have been made:

1. The material and production method of the front strut bearing (A) has been changed. (CX-5 and Mazda6)
2. A protector has been installed onto the coil spring. (CX-5 and Mazda6)
3. The shape of the bump stopper (C) will be modified in the future. (Mazda6 only)
4. The shape of the coil spring has been changed. (CX-3 only)
5. Friction of the lower arm bushing has been reduced by adding a dry coating. (CX-5 and Mazda6)

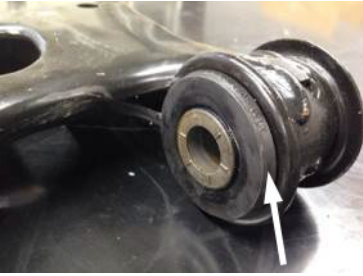
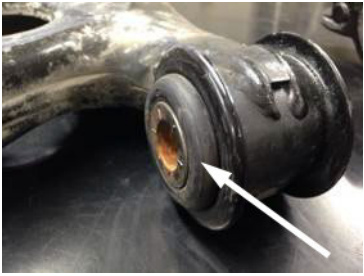
OK	NG
Tab is completely expanded	Tab is NOT completely expanded yet

CAUTION: Make sure that the bushing has been properly inserted by checking that the tab of the bushing is completely expanded as shown in the OK illustration.
