<b>Subject:</b>  <b>CHECK ENGINE LIGHT ON WITH DTC P0300-P0304</b>	<b>Bulletin No:</b> 01-014/16
	<b>Last Issued:</b> 07/29/2016

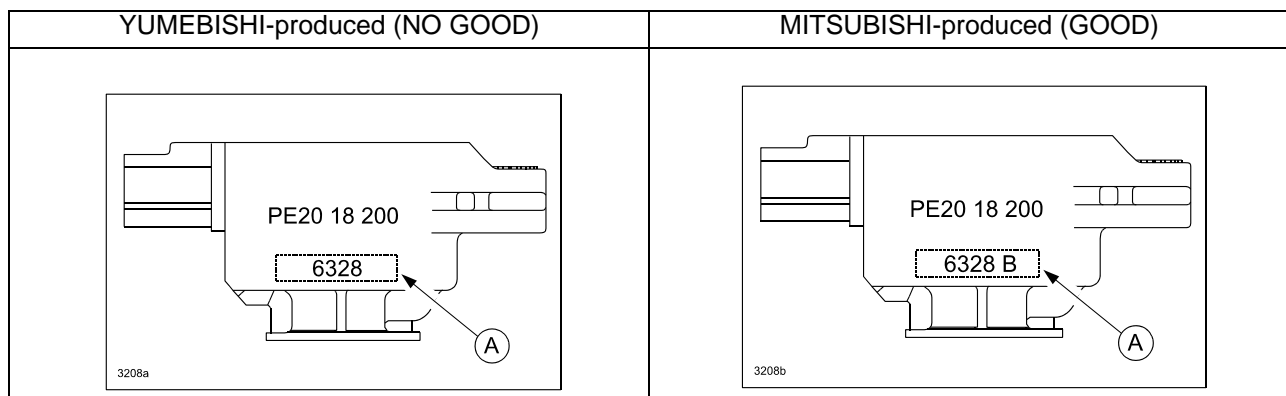
**NOTE:** The ignition coils are supplied from two different vendors, YUMEBISHI and MITSUBISHI. This concern only occurs on YUMEBISHI- produced ignition coil.

To distinguish between YUMEBISHI and MITSUBISHI ignition coils, look at their lot numbers (A). YUMEBISHI have 4 digit lot numbers and MITSUBISHI have 5 digit lot numbers as shown.

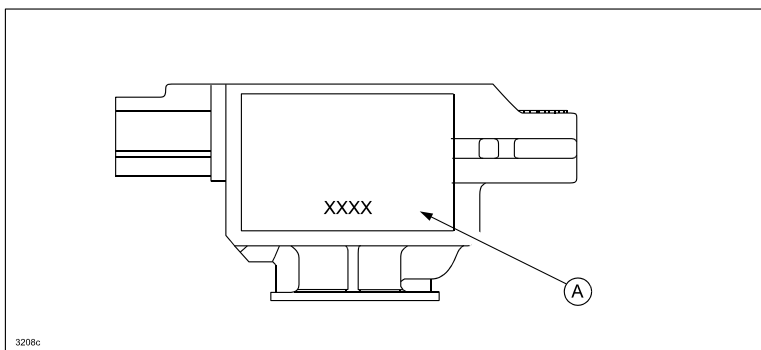
**NOTE:** There is no part number change. Differentiate the new modified ignition coil (YUMEBISHI-produced) from the old one by the lot number on the ignition coil. Ignition coils with the lot number of 6328 (March 28, 2016 production) or higher are modified.

4. Check if any of the other non-defective coils are YUMEBISHI-produced and made before lot number 6328 (March 28, 2016 production). If any were made before this date, replace them with modified one(s) as well.
