Subject: TPMS WARNING LIGHT ON	Bulletin No: 02-012/16
	Last Issued: 07/29/2016

2016 CX-3 equipped with AWD

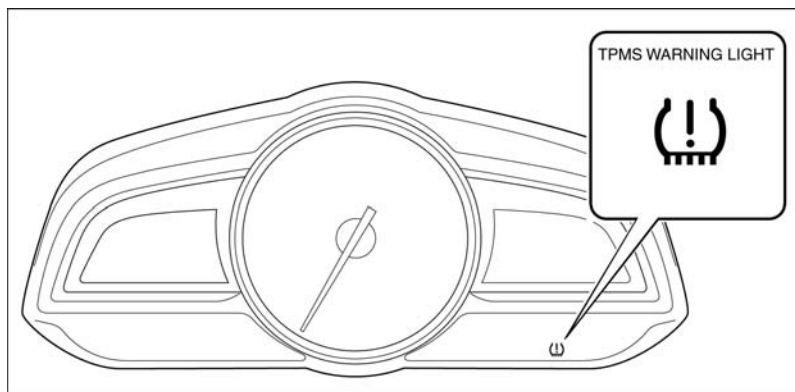
Some vehicles may experience a Tire Pressure Monitoring System (TPMS) warning light on when driving on a smooth road surface even if the TPMS system has been properly initialized at the specified tire air pressure.

The TPMS system may have been improperly initialized when the initialization was performed on certain types of rough road surfaces. Then, when driven on smooth road surfaces, the TPMS system may detect improper tire air pressure. The DSC HU/CM control logic has been changed for this concern.

1. Verify customer concern.
2. Are all four tire pressures at specification?
Tire Pressure Specification: Front; 36 psi, Rear; 33 psi
 - a. Yes - Go to step 3.
 - b. No - This service bulletin does not apply.
3. Replace the DSC HU/CM. Refer to MS3 Workshop Manual online DSC HU/CM REMOVAL/INSTALLATION.
NOTE: Rear brake pad replacement is necessary for proper brake system air bleeding.
4. With Mazda Modular Diagnostic System (M-MDS), perform the TPMS initialization. Refer to MS3 Workshop Manual online TIRE PRESSURE MONITORING SYSTEM INITIALIZATION PROCEDURE. This will initialize TPMS and disable the mis-use prevention logic at the same time.
5. Verify repair.
