September 30, 2016

04934 Version 1

## Rubbing, Popping or Clicking From Front Door When Opening

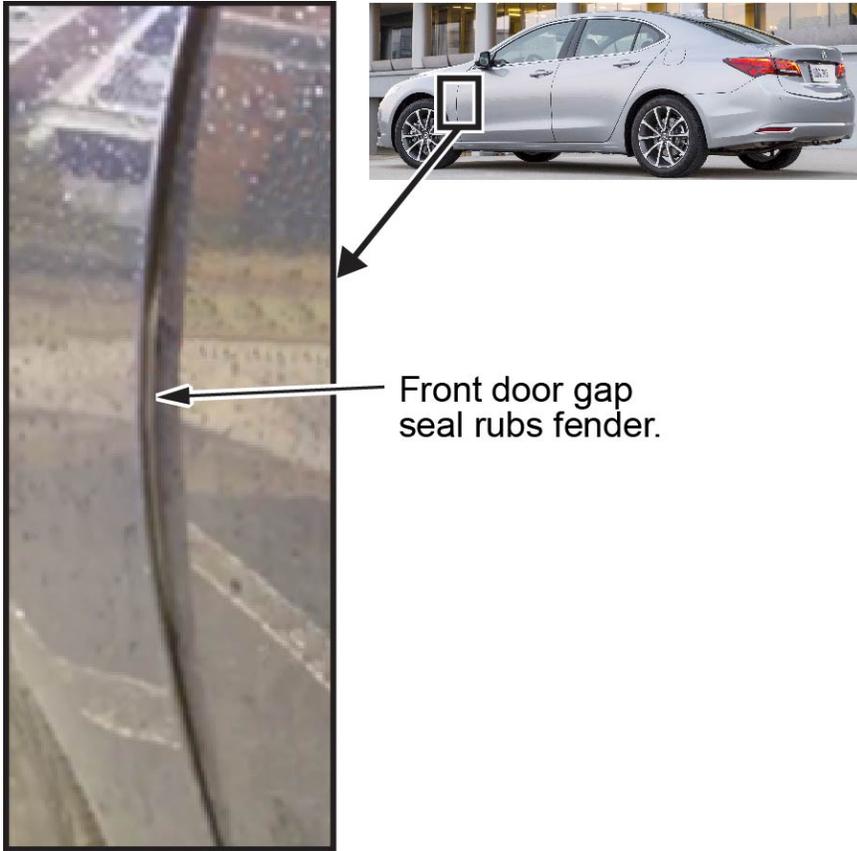
1. Identify the side making the noise by opening and closing the front doors.
