# MIL "ON" DTC P2440/P2442

**Service Category** Engine/Hybrid System

**Section** Emission Control

YEAR(S)	MODEL(S)	ADDITIONAL INFORMATION
2014 - 2016	Tundra	VDS(s): DM5F1, EM5F1, RM5F1, UM5F1

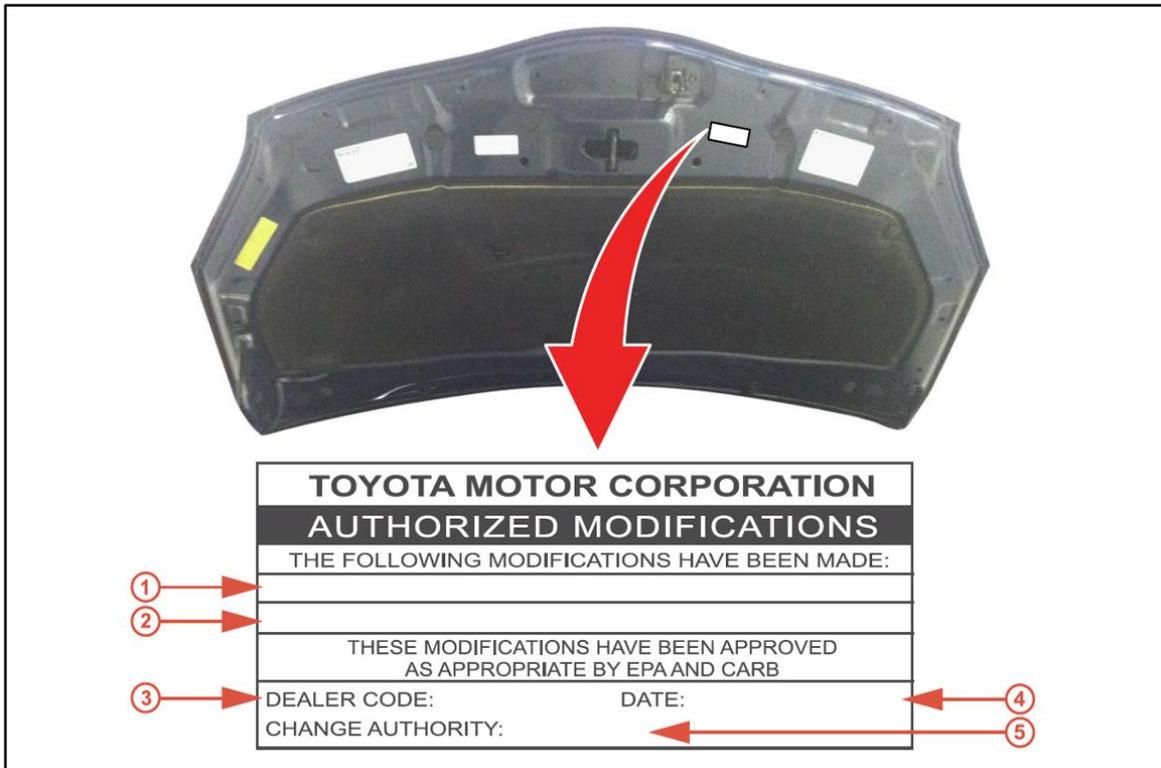
**Figure 1. Location of Authorized Modification label for 2014 – 2016 Tundra**

2. Check for the Authorized Modifications Label affixed to the vehicle in the location shown in Figure 1 below. Confirm if the ECM (PCM) calibration has been updated.  
Is the calibration ID listed NOT the latest ECM (PCM) calibration?
  - **YES** — Go to step 3.
  - **NO** — This bulletin does NOT apply. Continue diagnosis using the applicable Repair Manual.

- Install the Authorized Modifications Label.
  - Using a permanent marker, enter the following information on the label:
    - ECM part number [*Refer to the **Parts Information** section for the **NEW PART NUMBER***]
    - Calibration ID(s) [*Refer to the **Calibration Information** section for the **NEW CALIBRATION***]
    - Dealer Code
    - Repair Date
    - Change Authority [**This bulletin number**]
  - Affix the Authorized Modifications Label to the vehicle at the location shown in Figure 1. The Authorized Modifications Label is available through the MDC, P/N 00451-00001-LBL.
- Test drive the vehicle to confirm proper vehicle operation.
