Technical Service Bulletin
No. TS 01 51816

May 18, 2016
REVISED August 24, 2016

DAMAGE TO FRONT SIDE AIRBAG HARNESS Special Warranty Extension ZH

Affected Models: Certain 2005 - 2008 Forenza and Reno Vehicles (RQ)

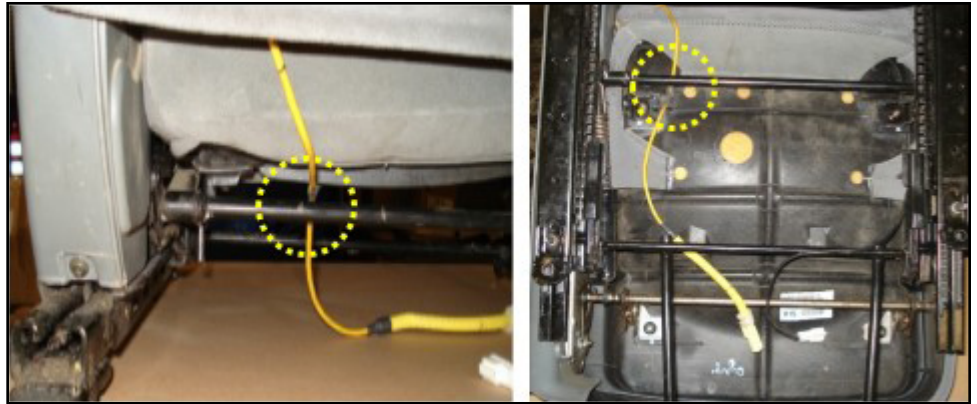
Damage from a failed Seat Height Adjuster

Damage to the SAB harness may be as severe as pictured or there may be only minor scuffing of the SAB harness yellow insulation covering.

- 7) Repair the SAB harness damage. See **Front Seat Wiring Harness Repair Procedure** on page 10.
- 8) Reinstall the seat in the vehicle. Refer to **Front Bucket Seat Removal and Installation** in the Suzuki Pit Stop PLUS Service Repair Manual.
- 9) Route the SAB harness per the instruction below. See **SAB Harness Routing** on page 15.
- 10) Enable the SIR system. Refer to **Enabling the Supplemental Inflatable Restraints (SIR)** in the Suzuki Pit Stop PLUS Service Repair Manual.
- 11) Using the scan tool, clear DTCs B1380, B1384 or B1379. If the DTCs cannot be cleared, replace the sensing and diagnostic module (SDM) with a new one. **Refer to Sensing and Diagnostic Module (SDM)** in the Suzuki Pit Stop PLUS Service Repair Manual.
- 12) Re-set the radio preset stations recorded in step 3 above.
- 13) Repairs are complete for this warranty extension.
