Subject		Market
Fuel Door Will Not Open Due To Detached Cable		USA
Service Category	Section	
Vehicle Exterior	Door/Hatch	
Applicability		
16MY iA

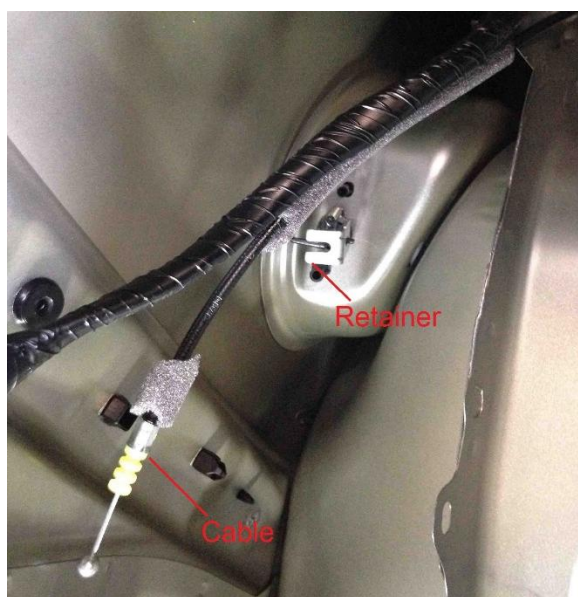
Fuel door will not open when pulling the release lever because fuel door cable has detached from the retainer.

This issue is currently under investigation.

- Please create a TAS case and contact Technical Assistance (TAS) to submit details on any vehicle identified matching the condition described in this document prior to repair.
- If you are attempting to contact TAS on a weekend or TMS holiday, continue with diagnosis and submit the requested information on the next available work day. Retain all replaced parts and technician notes for possible review with TMS TAS Product Engineer.
