Technical Journal

Active bi-xenon, headlamp service required message set in DIM

REF NO: TJ 23604	ISSUING DEPARTMENT: Technical Service	CAR MARKET: United States and Canada	
PARTNER: 3 US 7510 Volvo Car USA		ISSUE DATE: 2016-04-01	STATUS DATE: 2016-04-08
FUNC GROUP: 3521	FUNC DESC: Headlamp, complete	Page 1 of 5

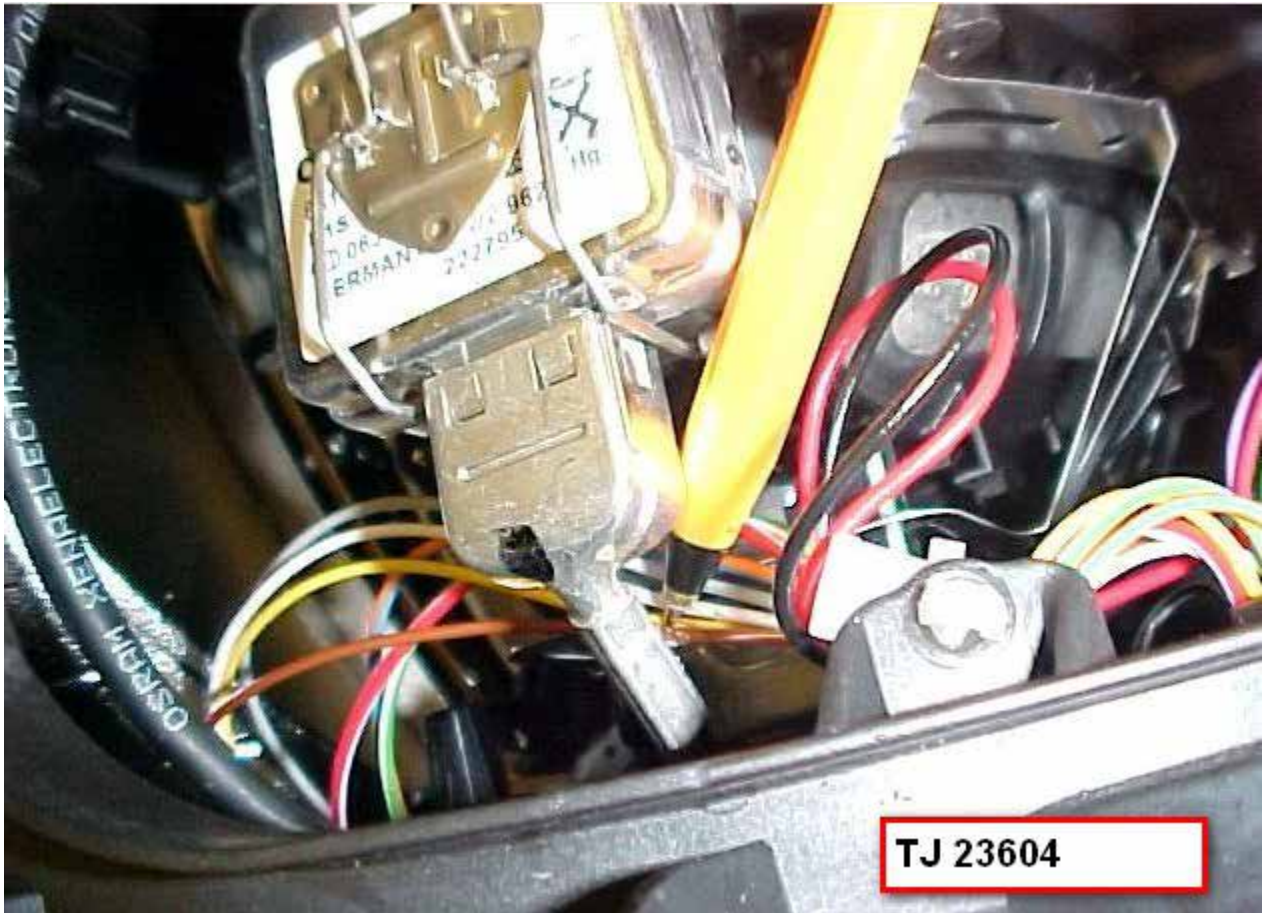
Headlamp service required message may be set in DIM. It may be set due to the routing of the headlamp harness, see pictures TJ23604_1.jpg, TJ23604_2.JPG.

Make sure that the harness is secured in the clip and that the cables are located as the red arrow C shows. Check that the connectors A (swiveling motor) and B (module) are correctly mounted, see picture TJ23604_3.JPG. Check if the DTC is cleared by reading fault codes again. If the fault code still is present, follow VIDA fault tracing for the fault code.
