Technical Journal

Volvo On Call App connection to Sensus Connect cars failsREF NO:
TJ 29697ISSUING DEPARTMENT:
Technical ServiceCAR MARKET:
United States and CanadaPARTNER:
3 US 7510 Volvo Car USAISSUE DATE:
2016-04-04STATUS DATE:
2016-04-08FUNC GROUP:
3975FUNC DESC:
Mobile data services, general

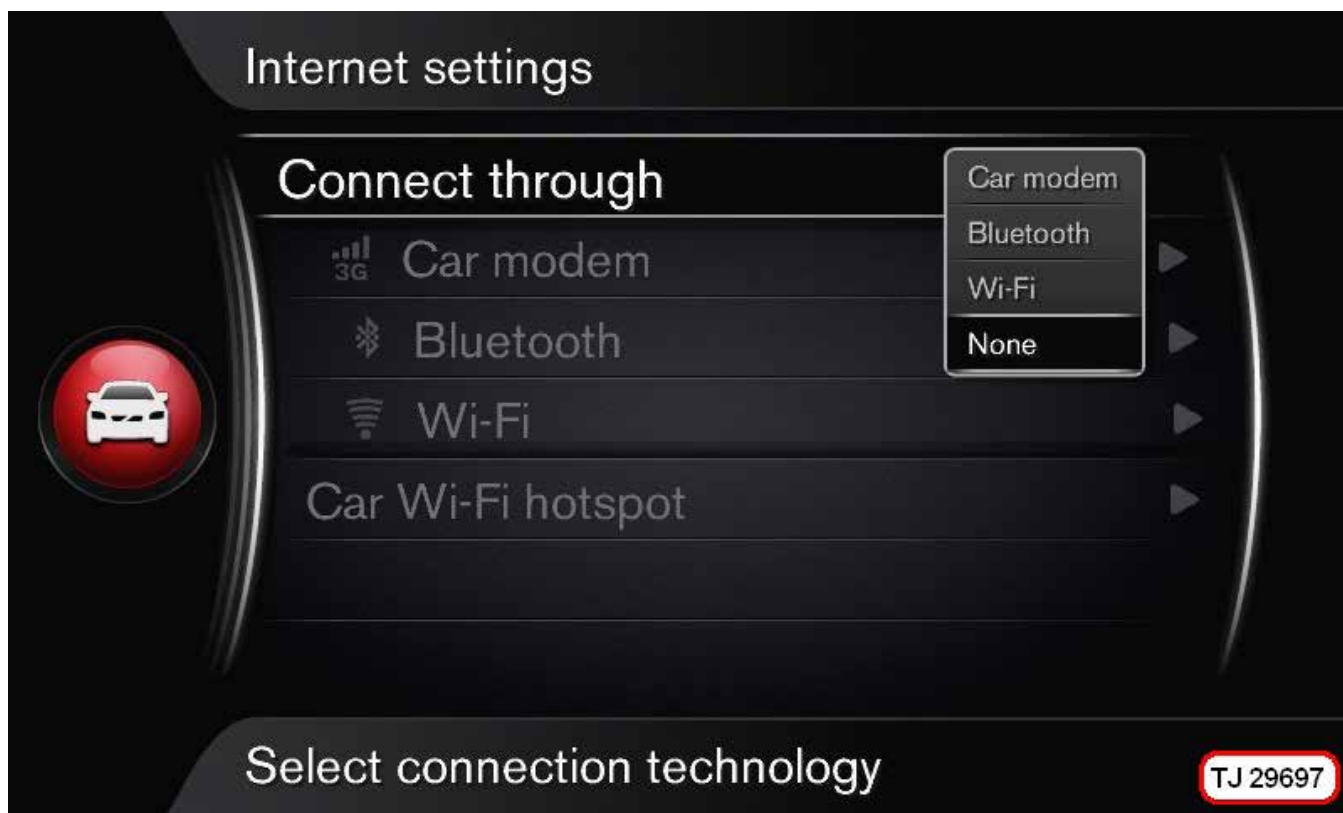
For information on the My Car Internet setting views, please see attached pictures "TJ 29697_0.jpg" and "TJ 29697_1.jpg".

1. Turn ignition or engine on and remove the P-SIM card from the slot in the glove box.
2. Check My Car and Internet settings. See attached picture "TJ 29697_0.jpg". Please change the setting from "None" to "Car modem".
3. Let the system start to search and then change the setting back to "None".
4. Turn ignition and/or engine off and close and lock the vehicle. Wait one minute.
5. Unlock the vehicle and make a new attempt to connect the Volvo On Call Mobile App to the car with the ignition turned on.

Make sure that Car modem is **NOT** selected as the Internet source in the infotainment system. If it is selected, you will not be able to complete the mobile app pairing process.
