Technical Journal

Tailgate, power operated tailgate

REF NO:
TJ 29700

FUNC DESC:
Boot lid; tailgate

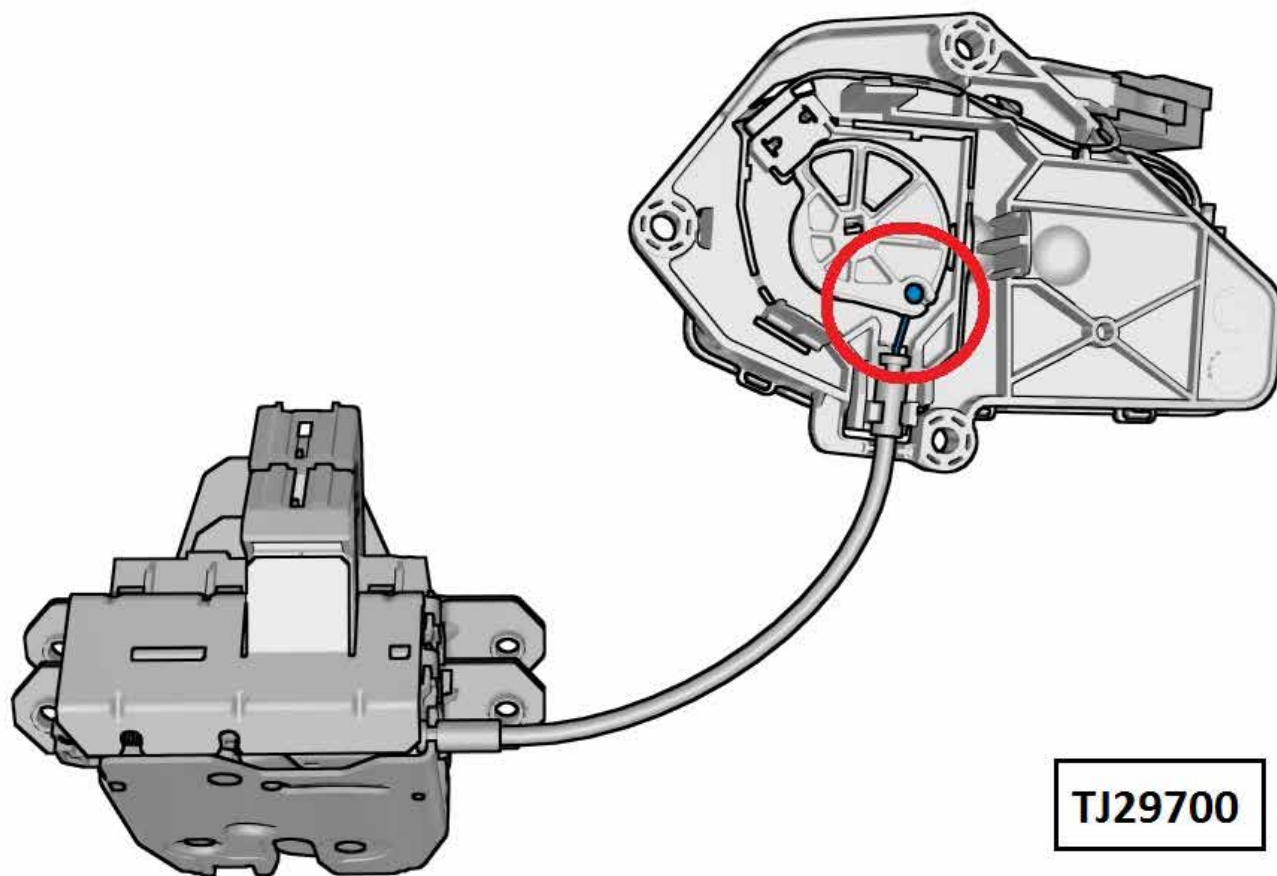
TJ29700

Customer may experience that the tailgate does not go into closed position when using the power operated tailgate.

Secure that the bowden cable ball is connected in the (PCU) power closing unit according to attached picture (TJ29700), if loose reconnect the bowden cable ball to the (PCU) power closing unit.
