Technical Journal

XC90 Courtesy Upgrade (C-10006)

REF NO: TJ 30991	ISSUING DEPARTMENT: Technical Service	CAR MARKET: United States and Canada	
PARTNER: 3 US 7510 Volvo Cars North America		ISSUE DATE: 2016-03-10	STATUS DATE: 2016-04-19
FUNC GROUP: 3600	FUNC DESC: Other electrical equipment	Page 1 of 10

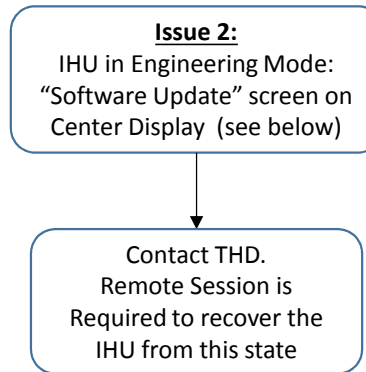
IHU stuck in engineering mode

Note: To speed this process up, please have someone with administrative access log into the VIDA station being used. The THD agent will need to install a special Volvo application to your machine in order to recover the IHU.
