# Technical Journal

TITLE:  
**Fender flares, poor fit**

<b>REF NO:</b> TJ 31446	<b>ISSUING DEPARTMENT:</b> Technical Service	<b>CAR MARKET:</b> United States and Canada	
<b>PARTNER:</b> 3 US 7510 Volvo Car USA		<b>ISSUE DATE:</b> 2016-04-19	<b>STATUS DATE:</b> 2016-04-22
<b>FUNC GROUP:</b> 8259	<b>FUNC DESC:</b> Miscellaneous	Page 1 of 3

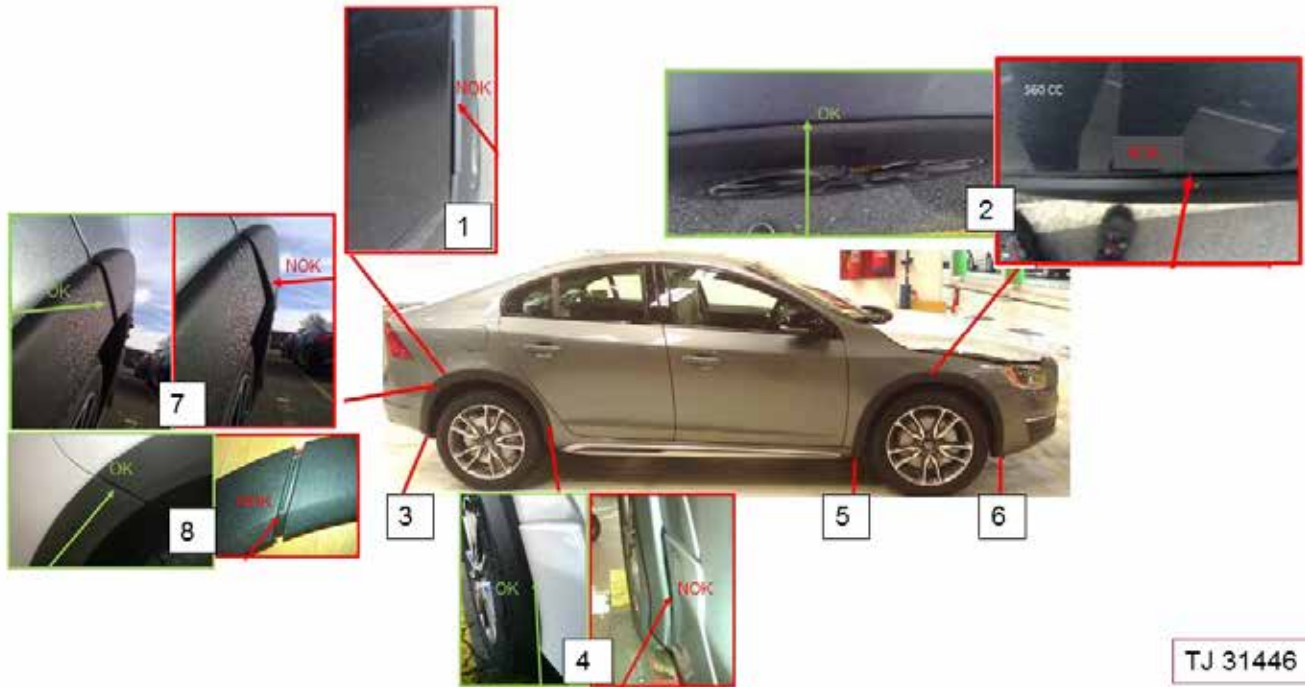
TJ 31446

The front and rear fender flares may have poor fit. Improvements have been implemented on parts from structure weeks above.

If a failure occurs after the breakpoint, please report back on which fender flare, and where the location of the failure is. See attached guideline to judge the failure.

Replace the fender flare according to VIDA. If a failure may occur on vehicles after above structure weeks, document the failure mode before the repair is done.

Add relevant information like comments and photos that describe the location of the failure. Take photos from different views.
