Technical Journal

Volvo On Call Service Required message and DTC B116F09REF NO:
TJ 31462ISSUING DEPARTMENT:
Technical ServiceCAR MARKET:
United States and CanadaPARTNER:
3 US 7510 Volvo Car USAISSUE DATE:
2016-04-06STATUS DATE:
2016-04-12FUNC GROUP:
3943FUNC DESC:
Telematics

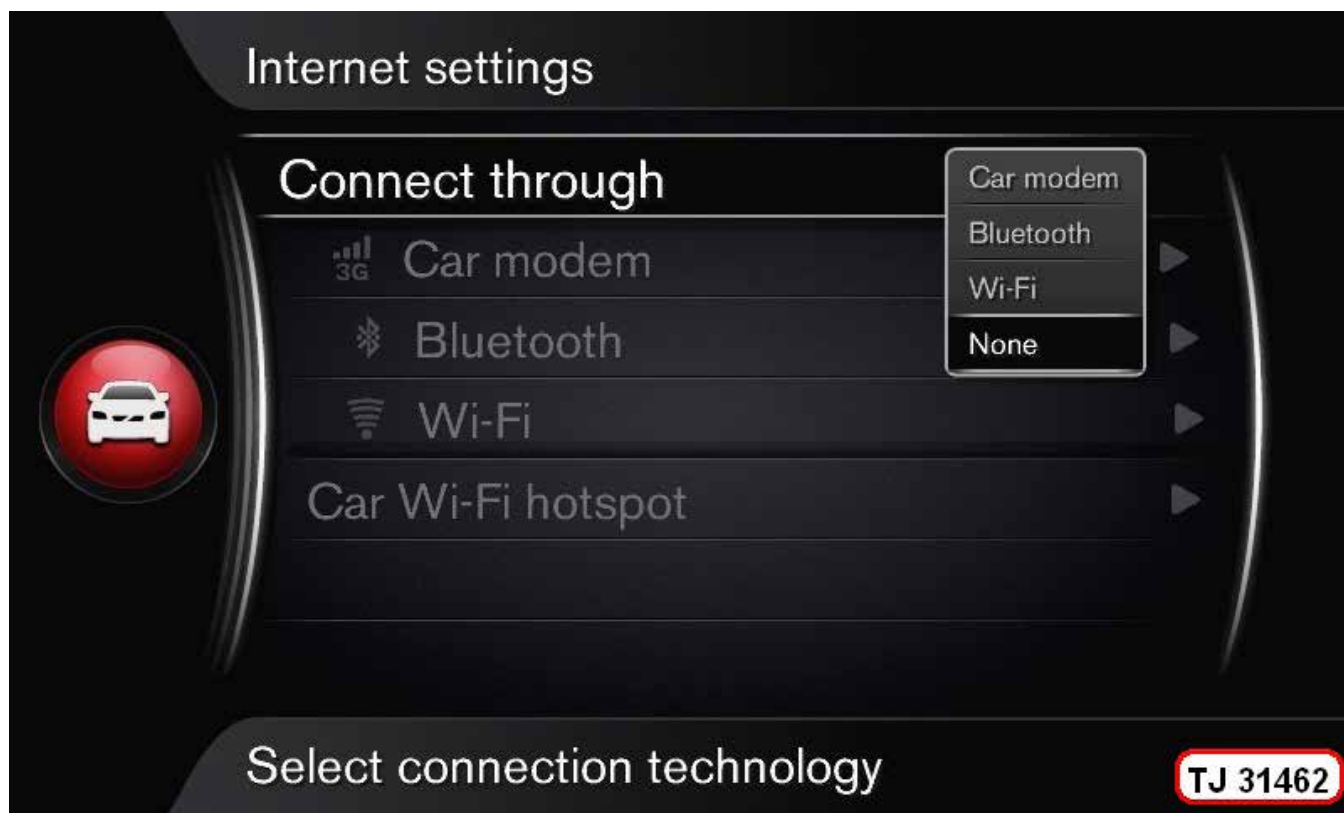
File Name	File Size
TJ 31462 .jpg	0.0889 MB

If a customer should complain of a “Volvo On Call Service Required” message and the DTC PHM-B116F09 is set intermittently or permanent in the TEM3G module, please follow the below instruction under **SERVICE**.

1. Erase the present DTC PHM-B116F09 if possible.
2. Turn ignition or engine on and remove the P-SIM card from the slot in the glove box (if present)
3. Check My Car and Internet settings. See attached picture “TJ 31462.jpg”. Please change the setting from “None” to “Car modem”.
4. Let the system start to search and then change the setting back to “None”.
5. Turn ignition and/or engine OFF and close and lock the vehicle. Wait at least one minute.
6. Read out DTC's with VIDA
7. If DTC PHM-B116F09 is not in the DTC list, the symptom should be considered solved.
8. If DTC PHM-B116F09 is read out as permanent, the PHM/TEM unit will need to be replaced in accordance with VIDA instructions.
