October 18, 2016

04934 Version 1

Rubbing, Popping or Clicking From Front Door When Opening

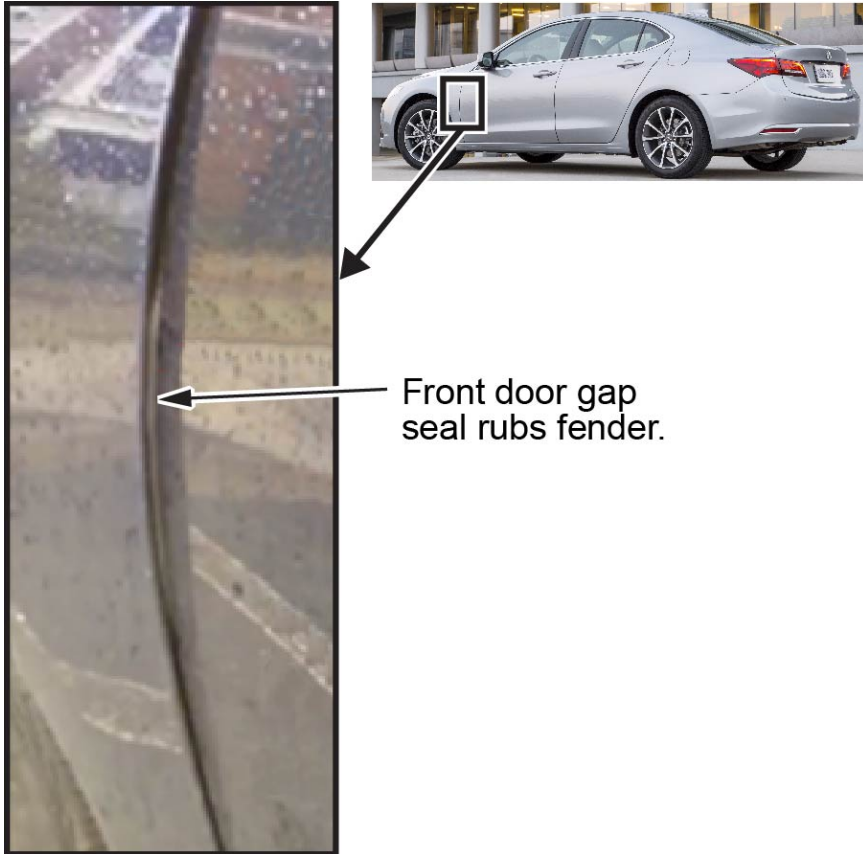
There is a rubbing, popping, or clicking type noise from one or both of the front doors when opened.

The door gap seal, on the leading edge of the front doors contacts and rubs against the front fender when opening the door.

1. Identify the side making the noise by opening and closing the front doors.
