Technical Journal

Fresh air hose loose from air filter housing

REF NO:
TJ 31913.1.0

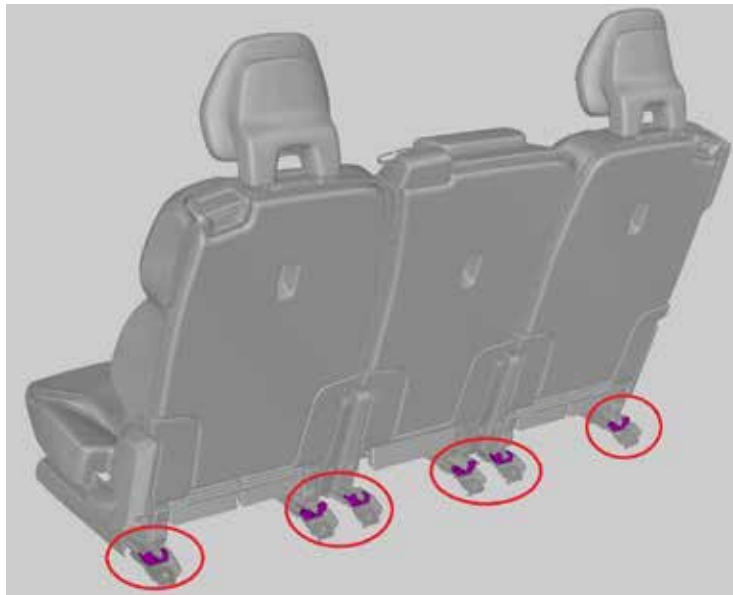
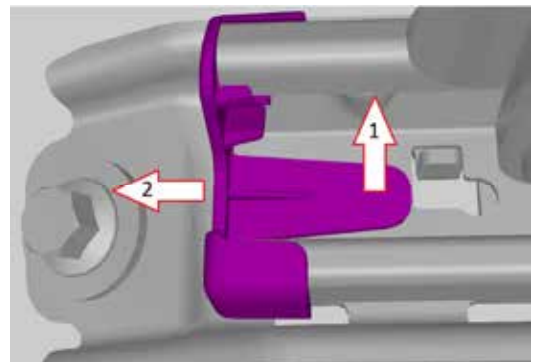
31913

Customer may experience a noise in second row seat while driving. This applies only for 7-seated cars.

Remove all 6 end caps as described in attached picture.
