Technical Journal

Fender flares, poor fit

REF NO: TJ 31446.1.1	ISSUING DEPARTMENT: Technical Service	CAR MARKET: United States and Canada	
PARTNER: 3 US 7510 Volvo Car USA		ISSUE DATE: 2016-09-22	STATUS DATE: 2016-09-28
FUNC GROUP: 8259	FUNC DESC: Miscellaneous	Page 1 of 3

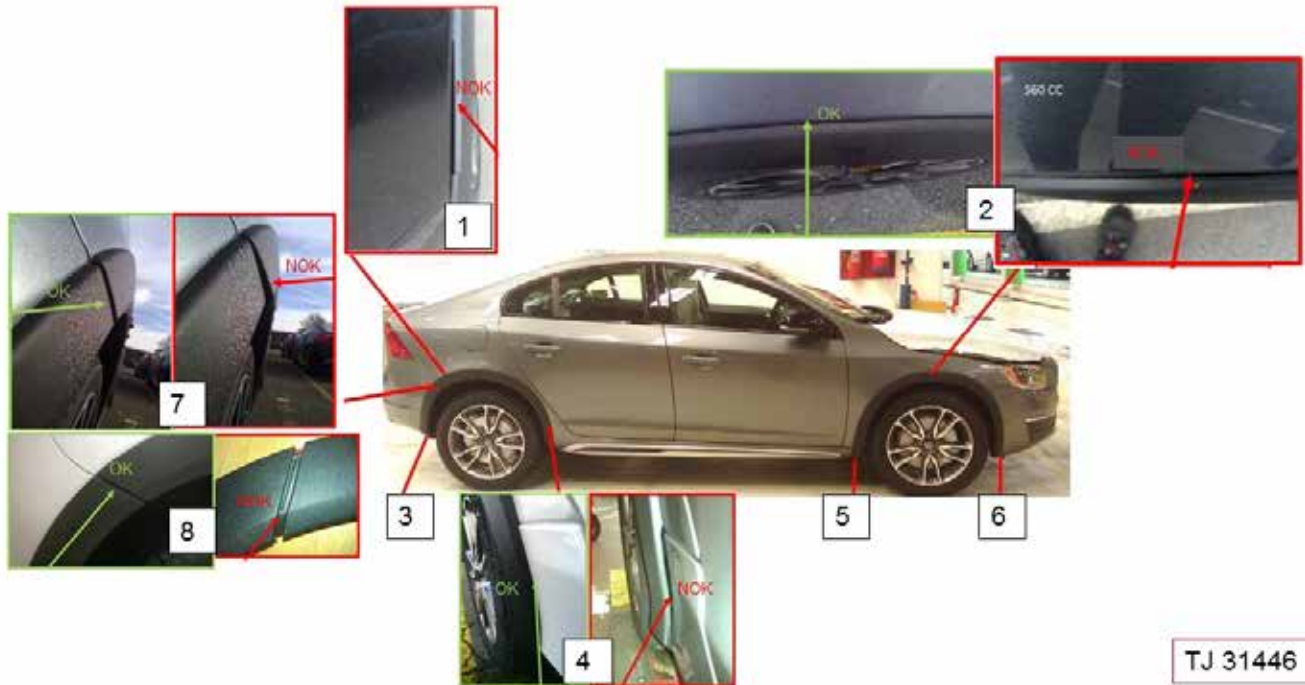
File Name	File Size
TJ31446.jpg	0.1079 MB

The front and rear fender flares may have poor fit. Improvements have been implemented on parts from structure week 16w05-> for V60CC and 16w08-> for S60CC .

If a failure occurs after the breakpoint, please report back on which fender flare, and where the location of the failure is. See attached guideline to judge the failure.

Replace the fender flare according to VIDA. If a failure may occurs on vehicles after above structure weeks, document the failure mode before the repair is done.

Add relevant information like comments and photos that describe the location of the failure. Take photos from different views.
