MIL "ON" DTC P2440/P2442

Service Category Engine/Hybrid System

Section Emission Control

YEAR(S)	MODEL(S)	ADDITIONAL INFORMATION
2014 - 2016	GX460

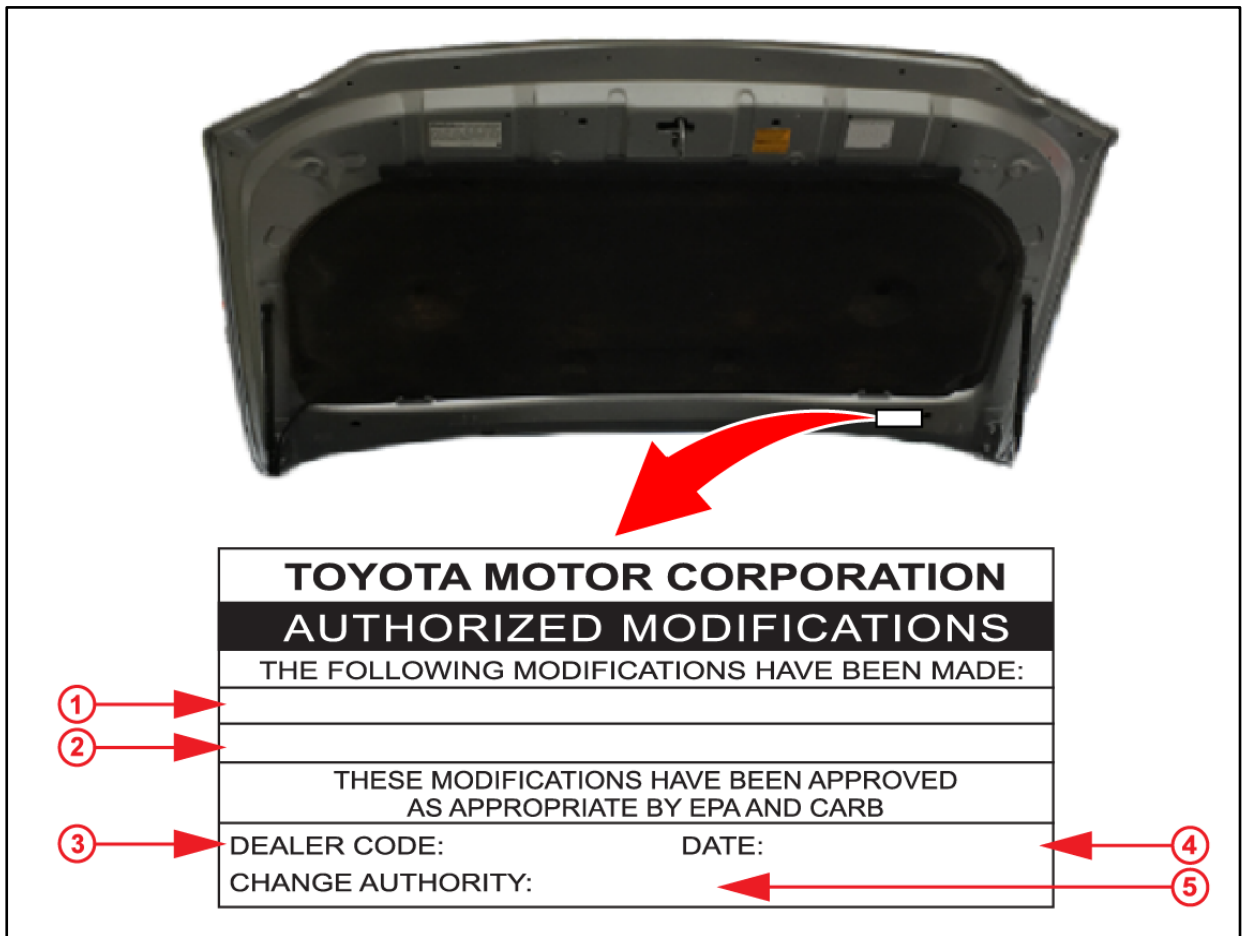
Figure 1. Location of Authorized Modification Label for 2014 – 2016 GX 460

- Check for the Authorized Modification Label affixed to the vehicle in the location shown below. Confirm the ECM (PCM) calibration has been updated.

4. Install the Authorized Modifications Label.
 - A. Using a permanent marker, enter the following information on the label:
 - ECM part number [*Refer to the **Parts Information** section for the **NEW PART NUMBER***]
 - Calibration ID(s) [*Refer to the **Calibration Information** section for the **NEW CALIBRATION ID***]
 - Dealer Code
 - Repair Date
 - Change Authority [**This bulletin number**]
 - B. Affix the Authorized Modifications Label to the vehicle at the location shown in Figure 1. The Authorized Modifications Label is available through the MDC, P/N 00451-00001-LBL.
5. Test drive the vehicle to confirm proper vehicle operation.
