## Technical Service Bulletin

**16-01-042**

**GENESIS COUPE (BK)**

PASSENGER OCCUPANT DETECTING SENSOR (PODS) UNIT  
CONNECTOR REWORK (RECALL 151)

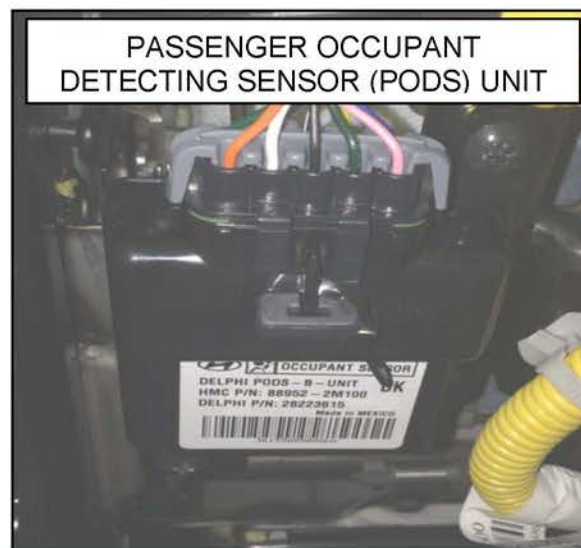
**Description:** The Hyundai Genesis Coupe is equipped with an Occupant Classification System (OCS) to determine if the front passenger seat is occupied, and if so, detect the presence of a Child Restraint System or small statured occupant. In certain cases, the front passenger airbag is deactivated to help prevent airbag-related injuries to the front passenger. If objects are placed under the front passenger seat that contact the OCS connector, the connector can become disconnected, illuminating the Air Bag warning lamp in the instrument cluster. If this occurs, the front passenger airbag will deploy in a frontal collision regardless of the front passenger seat occupant. Additionally, the system's second stage airbag will not deploy in more severe collisions.

This bulletin provides the procedure to inspect and secure the connector to the Passenger Occupant Detection Sensor (PODS) module underneath the front passenger seat.

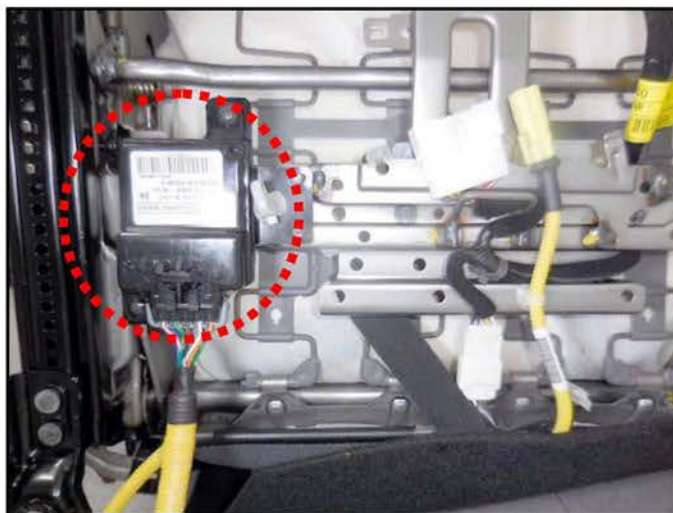
- 6. Locate the PODS unit under the seat.

Confirm the harness is fully seated in the PODS unit.

If the harness is disconnected from the PODS, then reconnect and confirm it is fully seated.
