Service Bulletin

Bulletin No.: 16-NA-193

Subject: Loss of Propulsion, No Start, Multiple DTCs

Brand:	Model:	Model Year:		VIN:		Engine:	Transmission:
		from	to	from	to		
Chevrolet	Volt	2016	2017			All	All

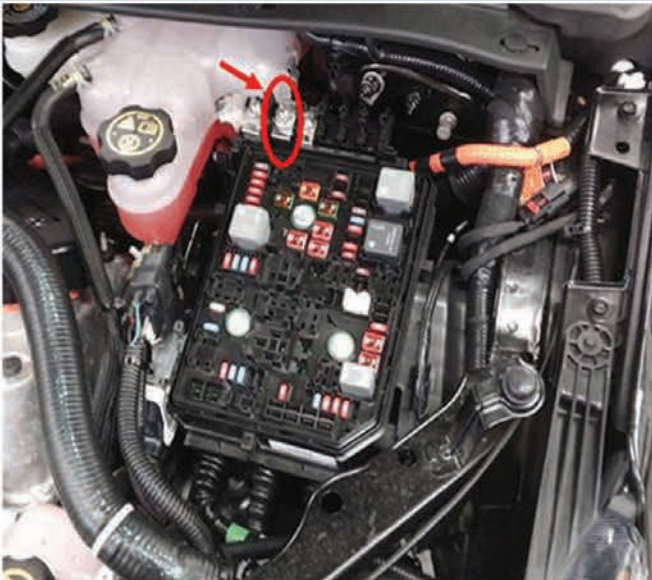
4533040

This may be caused by a loose or improperly installed battery cable for circuit #40 at the X50B auxiliary fuse box right above the underhood electrical center.

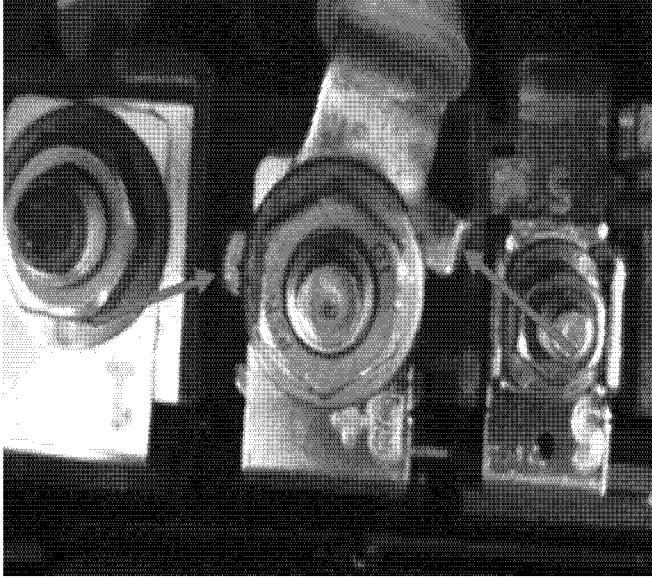
4533041

2. Check the terminal and make sure that the terminal is straight and the tabs are properly in the fuse box. Above is a picture of a terminal that was improperly installed.

Note: The tabs of the terminal are stuck on a plastic boss of the fuse block which causes the nut to be tight but the terminal is not flush in the fuse box, which causes a poor connection with the bus bar in the fuse box.

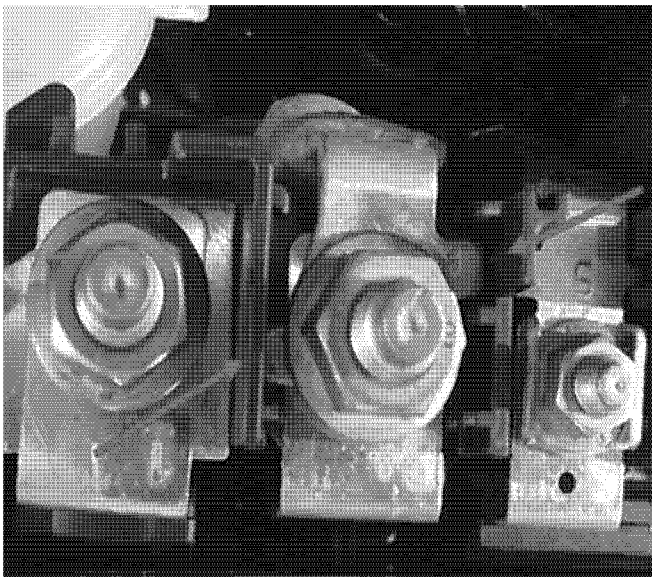
4533043

Note: See photo above of a properly installed terminal. Notice that the terminal tabs are located in the proper recess of the fuse box.

3. If the connection above is properly seated and torqued (torque requirement D15+/ 2 NM S13-17 NM) on the vehicle as pictured in the photo above, check all the connections at the X50D fuse box that is located on the side of the 12V battery.
