Technical Journal

Tailgate, power operated tailgate

REF NO: TJ 29700.6.0	ISSUING DEPARTMENT: Technical Service	CAR MARKET: United States and Canada	
PARTNER: 3 US 7510 Volvo Car USA		ISSUE DATE: 2016-10-21	STATUS DATE: 2016-10-25
FUNC GROUP: 8321	FUNC DESC: Boot lid; tailgate	Page 1 of 3

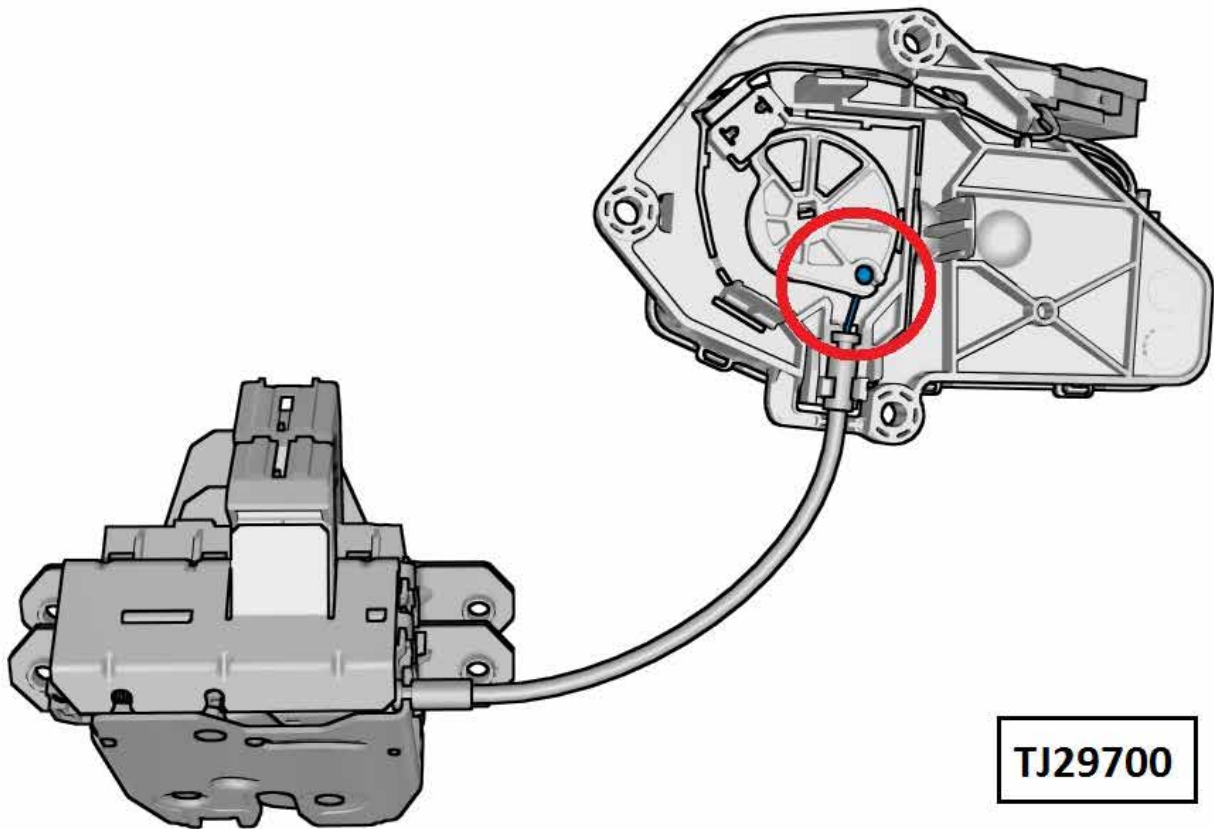
TJ29700

Customer may experience that the tailgate does not go into closed position when using the power operated tailgate.

Verify that the bowden cable ball is connected in the (PCU) power closing unit according to attached picture (TJ29700), if loose reconnect the bowden cable ball to the (PCU) power closing unit.
