Service Bulletin

Subject: HVAC Air Inlet Door Noise

Brand:	Model:	Model Year:		VIN:		Engine:	Transmission:
		from	to	from	to		
Cadillac	XT5	2017	2017			All	All

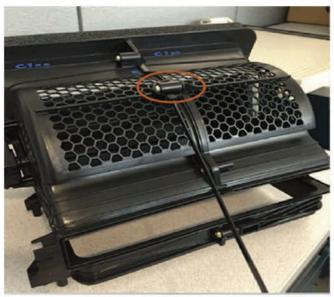
4531610

Involved Region or Country	North America		
Condition	Some customers may comment on hearing a noise coming from the HVAC, behind the glove box area.		
Cause	The cause of the condition may be a mis-alignment of the air inlet housing case halves, creating an interference with the air inlet door during closing.

Note: The air inlet housing is shown removed from the vehicle for illustration purposes only. The service procedure below is accomplished with the housing in vehicle position.

Add a tie strap to the air inlet housing to better align and secure the two halves.

Locally obtain a tie strap, approximate dimensions: 3.81–5.08 mm (0.15–0.20 in) wide, 1.25–1.52 mm (0.05–0.06 in) thick and 140 mm (5.5 in) long and follow the Service Procedure below.
